SERVICE INFORMATION LETTER

SUBJECTS: Cargo Net Damages, Repairs and Replacements.

This SIL is applicable to Single Stud fittings and Webbing used on AmSafe manufactured Underfloor Hold Nets.

SIL NUMBER: K2429-50-003
PAGE: 4 of 13
DATE: Jun 15/09
REVISION: 01, Sep 05/11

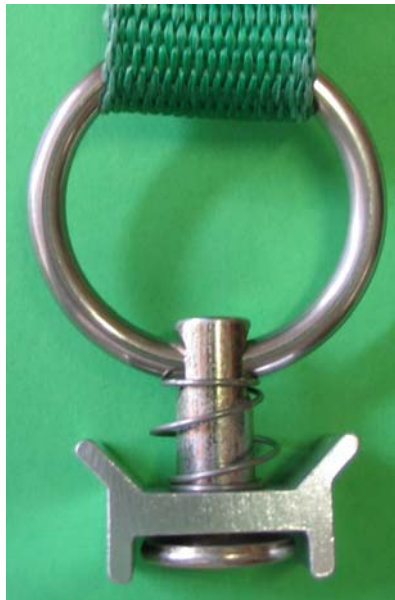
Single Stud Fitting
No Damage to Spring

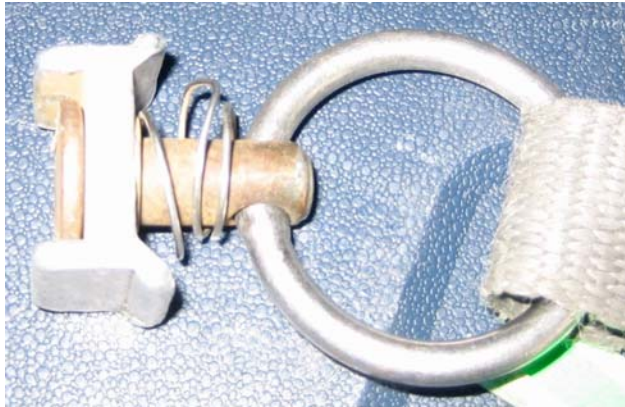
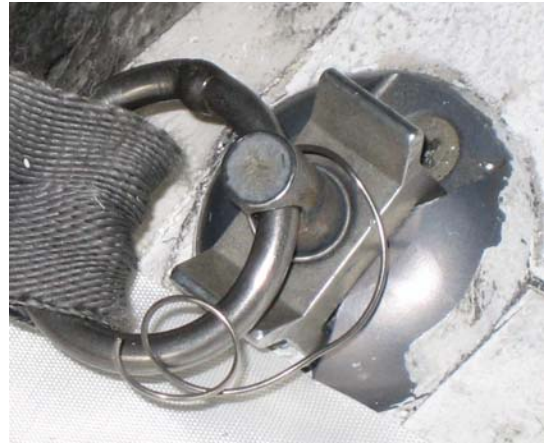
Single Stud Fitting
Damaged Spring

Single Stud fittings with damaged springs or no springs, as shown in paragraph 3, fall into the category of MAJOR damage and therefore the Net is not airworthy* (see page 3).

The function of the “Spring” is to ensure that the “Retainer” is positively held into the mating Aircraft Seat Track or Anchor Plate. If the Spring is damaged or missing then this positive retention is not there and the Single Stud could be inadvertently released from the Aircraft Seat Track or Anchor Plate. This means that the Net could become partially detached in flight with potential consequences. This is the reason why such damage to the Single Stud is classified as MAJOR damage and therefore the Net is not airworthy* (see page 3).

The classification of damaged or missing springs is self evident to the operators, as this is clearly a ‘damaged peripheral fitting preventing proper connection to the airframe’, as detailed in the Check section of the CMMs. However, the purpose of this SIL is to clarify the matter. i.e. It is classified as MAJOR damage and therefore the Net is not airworthy*. The Net must be repaired or replaced.

- (i) Using pliers, remove damaged spring from the single stud fitting and discard.

- (i) Place the spring onto the top of the stud.
- (ii) Pull open the lower end of the spring and then rotate the spring around the stud and under the ring, see Figures 1 and 2.

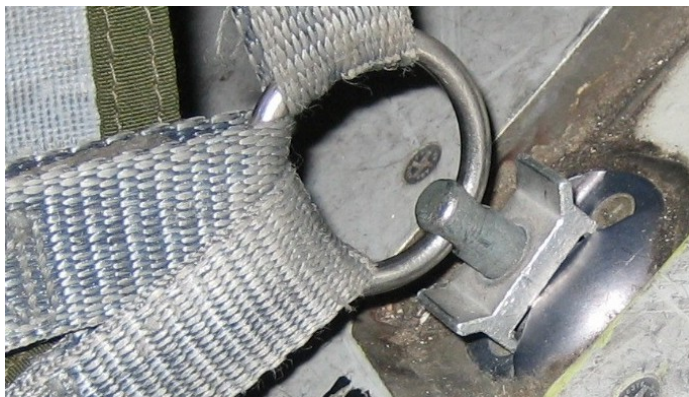
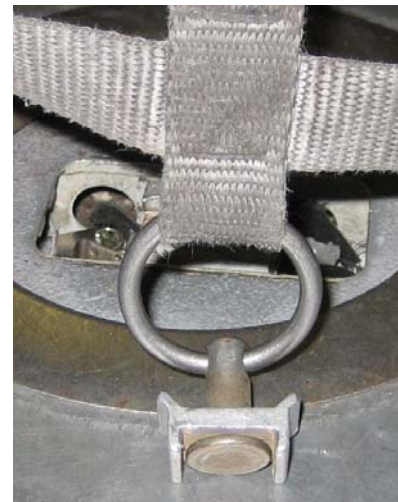
Single Stud Fitting
Missing Spring

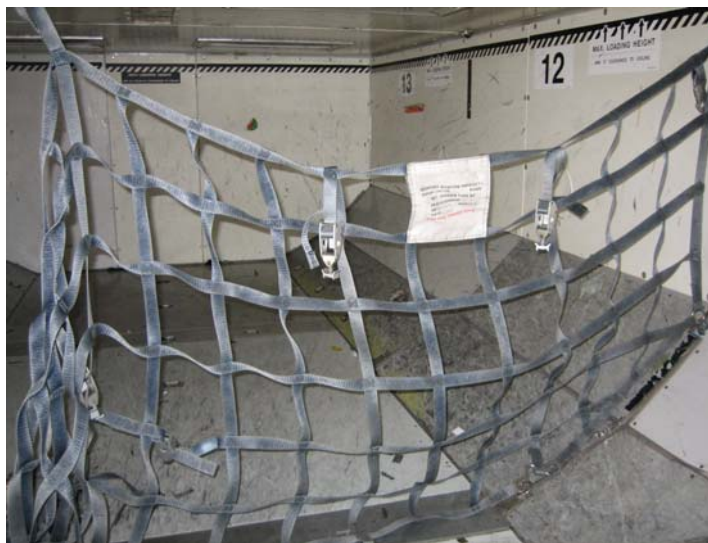
The first picture shows an Underfloor Hold Net that has been in service for a number of years. The Net is in good condition and is serviceable. Discolouration of the Webbing can be seen, there is some Soiling (Label and Webbing), these are ALLOWABLE and there is No Restriction on the Nets use.

Discolouration of Webbing / Soiled Label

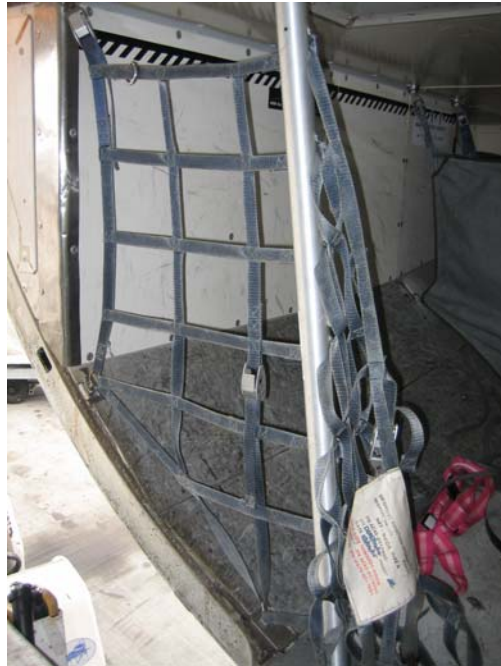
The next two pictures show further examples of Underfloor Hold Nets that have been in service for a number of years. These Nets are in good condition and serviceable. Again Discolouration, Soiling and some Fluffing and Slight Abrasion (close-up picture shows the Fluffing and Slight Abrasion) of the Webbing can be seen. These are ALLOWABLE and there is No Restriction on the Nets use.

Webbing - Discolouration / Soiling / Fluffing / Slight Abrasion

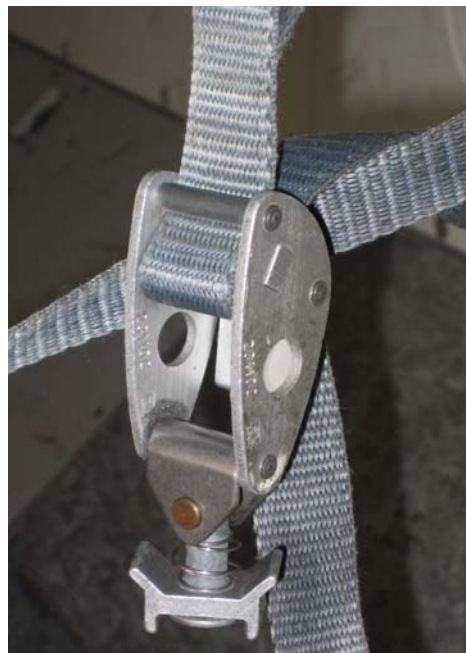
Webbing – Slight Abrasion

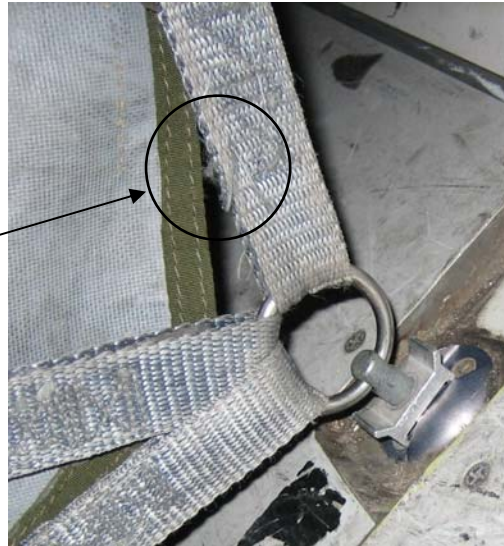
Webbing that is partially cut or severed is also damaged and needs to be classified as MAJOR and therefore the Net is Not Airworthy* (see page 7). i.e. The Net must be repaired or replaced. This includes webbing where there is clear evidence that the webbing yarn has been cut or severed. The next three pictures show examples of cut or severed webbing / yarns.

Webbing yarn has been cut or severed

Webbing Yarn Cut

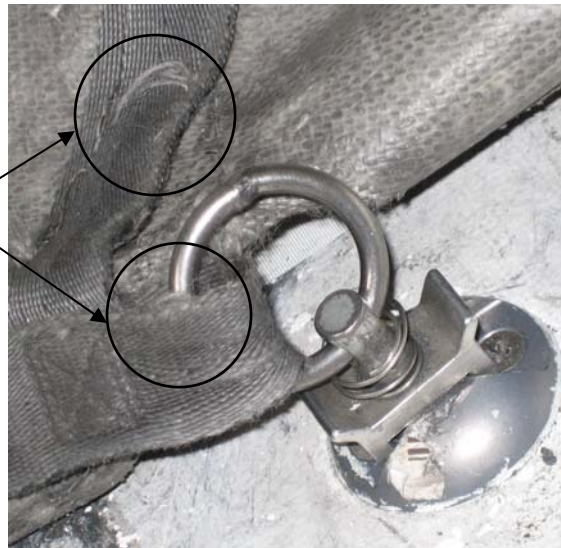
Webbing yarn has been cut or severed

Webbing Yarn Cut

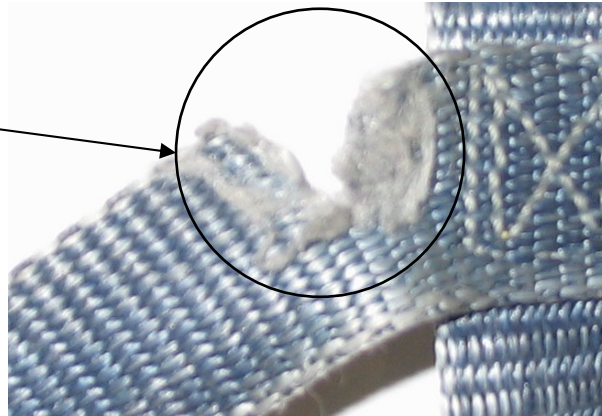
Webbing has been cut or severed

Cut / Severed Webbing

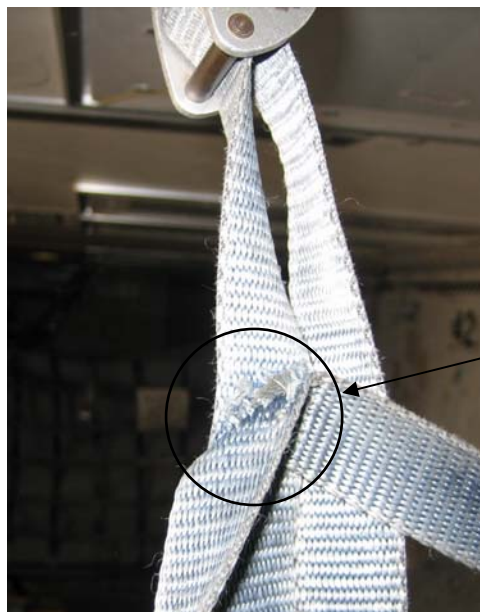
The next damage aspect is that of broken stitching or severely abraded stitching at the webbing intersections or the stitching flag patterns that attach the peripheral fittings (Net hardware or Net metalwork) to the net. Depending on the location of the broken stitching this is classified as either MAJOR or MINOR damage. In the case of 'MAJOR' the Net is not airworthy* (see page 7) and it must be repaired or replaced. In the case of MINOR, restrictions must be imposed on the Net and the Net shall be marked appropriately to notify operating personnel. This damage should be repaired at the earliest possible opportunity to avoid increase of damage and/or malfunction.

Broken stitching

With damage that is classified as 'broken stitching' as shown in the above 3 pictures, it is easy to overlook the fact that actually the webbing is cut or severed. Closer examination of the pictures shows this to be the case - the picture below also shows this. If two criteria of damage are evident the most severe classification must be adhered to.

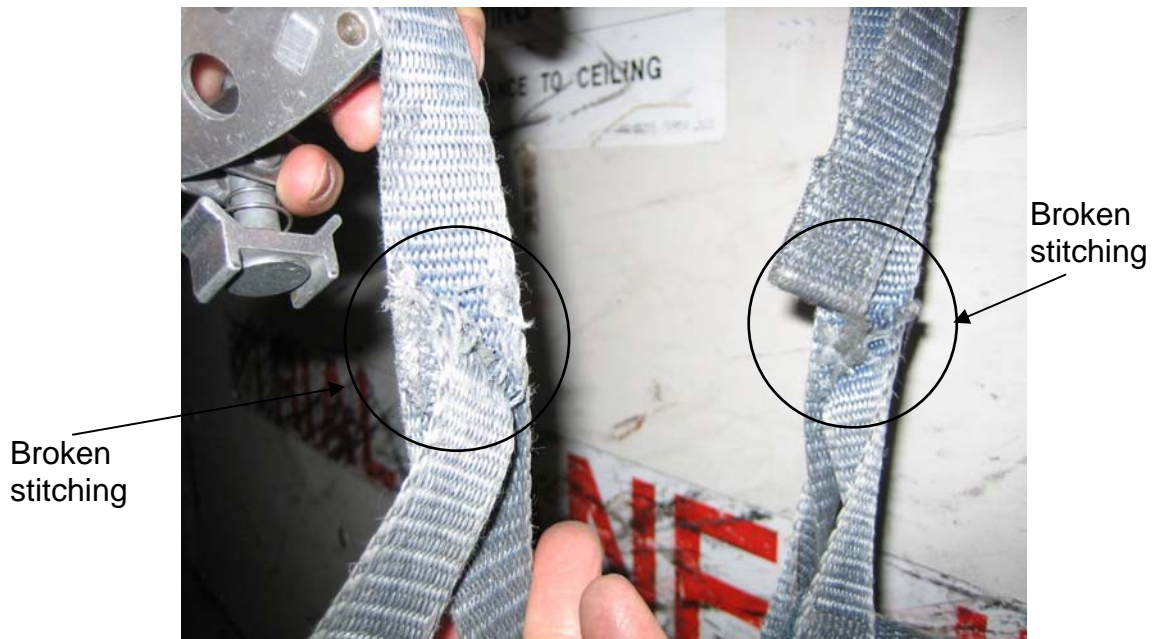
Broken Stitching

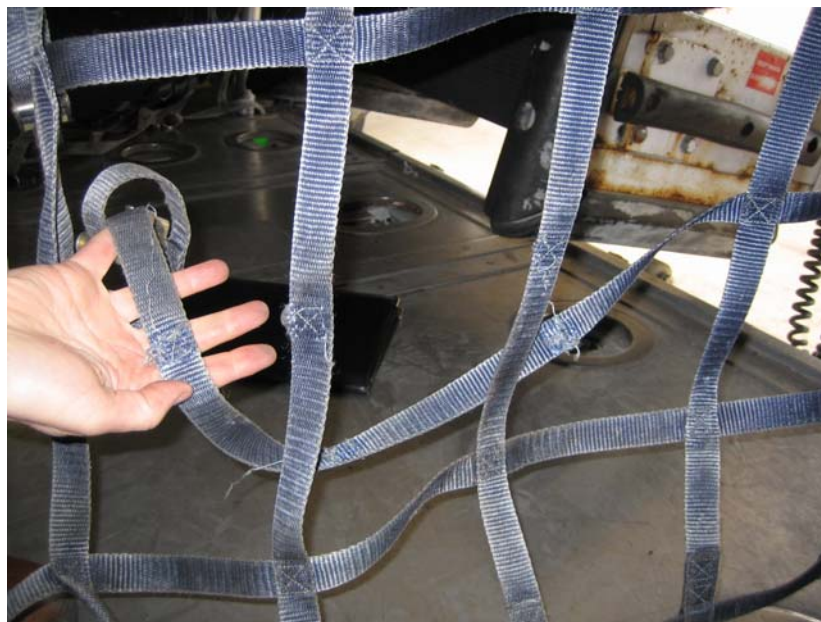
Broken Stitching

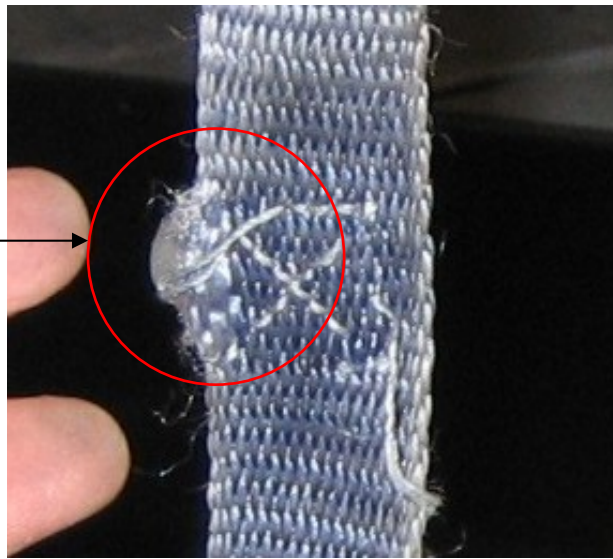
Webbing Yarn is cut or severed and also there is broken stitching

Broken Stitching and Webbing Yarn Cut
