# ALERT SERVICE BULLETIN

REPLACEMENT OF ROTARY BUCKLE

SERVICE BULLETIN NUMBER  
1150004-25-A01  
ISSUE 7

ISSUED BY:  
AMSAFE INC.  
1043 N. 47<sup>th</sup> AVENUE  
PHOENIX, AZ USA 85043  
TEL: (602) 850 2850 FAX: (602) 850 2812

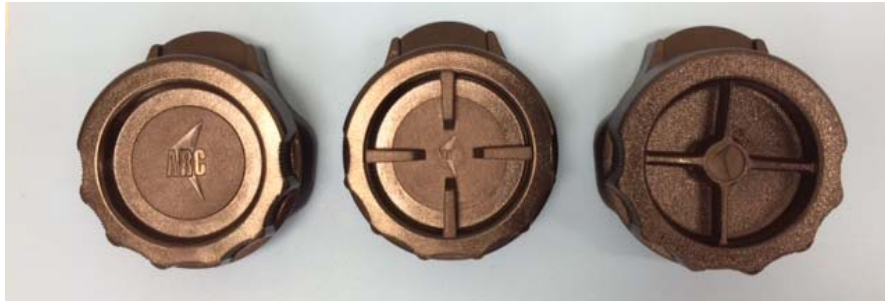
Figure 1: 1150004-SERIES Rotary Buckles

This Service Bulletin is applicable to the Restraint System Assemblies installed on the pilot and co-pilot seats using the 1150004-SERIES Rotary Buckles (see Figure 1) manufactured December 2013 to April 2016.

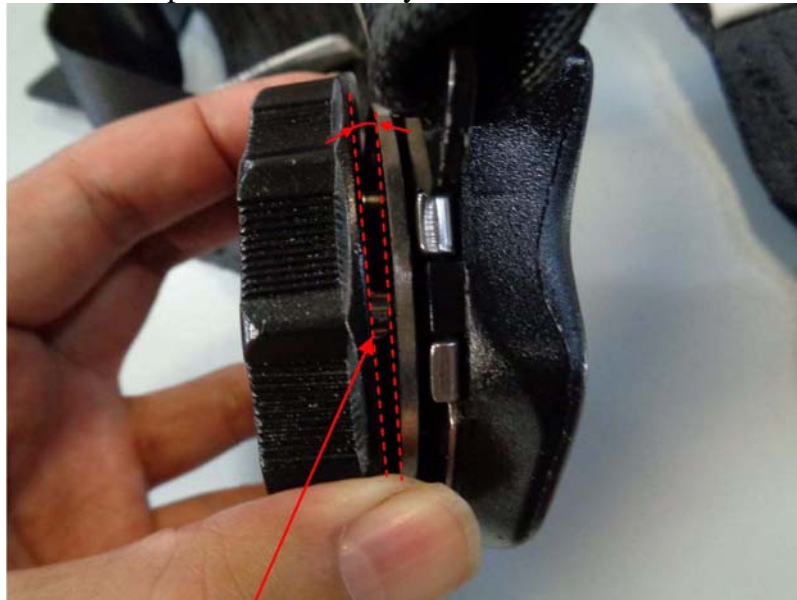
**Figure 2: Inspect the Cover for Looseness**

indicated in paragraph 1.A., (see Paragraph 2.A. for information on identifying the build date) then no further action is necessary. If the buckle build date is within the date range of this service bulletin, or if the build date is illegible or missing, check the buckle cover (front face that rotates to release the buckle). Viewing the buckle from the side, grasp the cover with one hand and attempt to rock the cover back and forth relative to the parallel plane of the buckle base (See Figure 2). If the cover is able to rock, so that there is a changing gap width between the buckle cover and buckle base, then the buckle must be replaced immediately.

If the above condition does not exist, the restraint can be returned to service, the buckle to be replaced within 180 days of the inspection, during a suitable maintenance interval, per §2 (Accomplishment Instruction). Buckles replaced under this service bulletin, whether due to manufacturing date within the build dates indicated or an illegible manufacturing date on the label shall be free of charge.

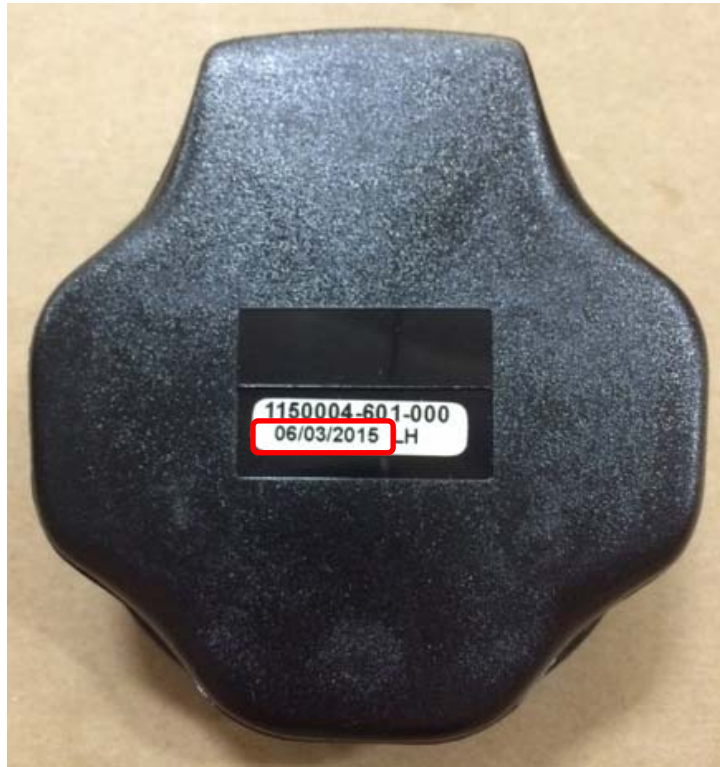
Figure 3: Manufacturing Date Found on Buckle Label

1. Find the label attached to the back surface of the buckle (see Figure 3).
