SERVICE BULLETIN

INSPECTION / REPLACEMENT OF EJECTOR BASE

**SERVICE BULLETIN NUMBER
504443-25-02
ISSUE 10**

Date: 10 February 2016

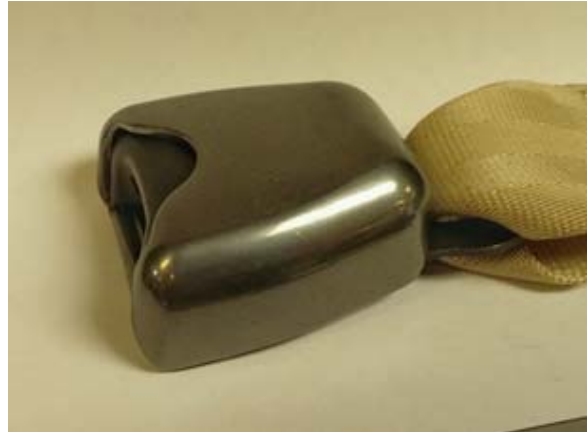
Inspections have found that the 505703-Series Compact End Release Buckle is not exhibiting the condition that was cause for the Service Bulletin. The reason for this is an as-cast feature that only exists in the Compact End Release Buckle Housing. This feature captures the subject Ejector Base, thereby not allowing the Ejector Base to deflect.

Figure 2: 505703-Series Buckle, Unaffected by Service Bulletin
