SERVICE BULLETIN

Missing Groove Pin in End-Release Buckle

All Aircraft Types Affected

SB504744, Issue: 4
Page: 1 of 13
Date: 24-Apr-2019

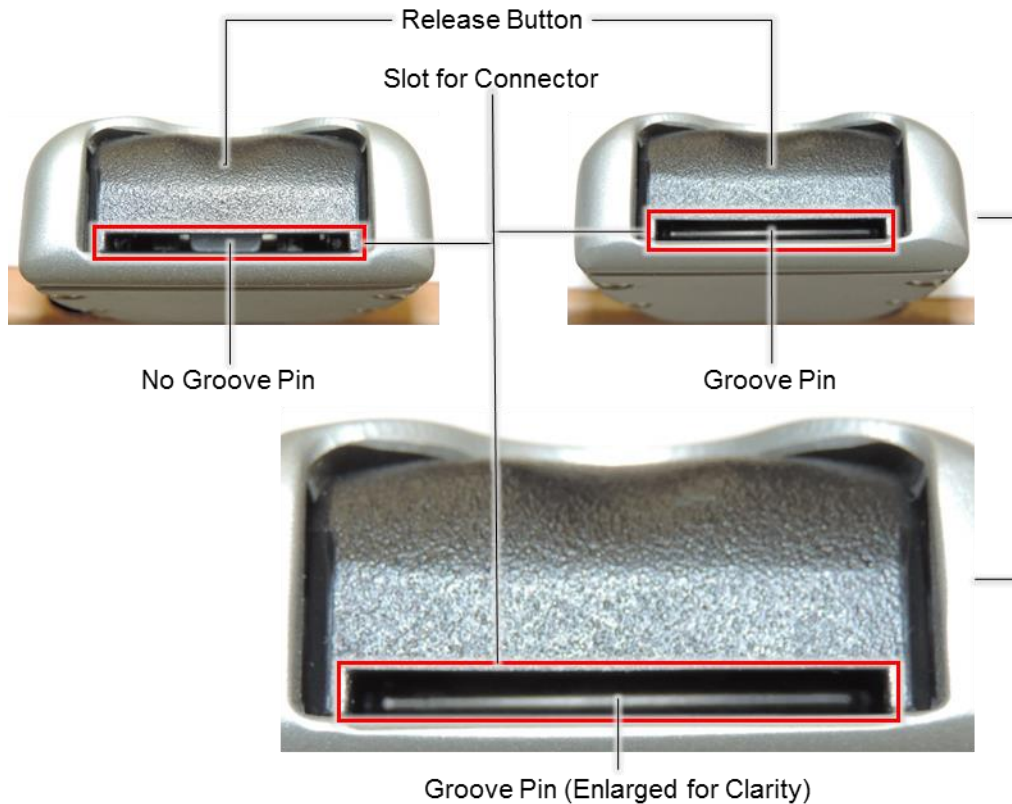
Figure 2 – Buckle and Groove Pin

The end release buckle on the restraints listed in section 1.1 may not contain the groove pin. Affected restraints with a missing groove pin meet the minimum performance standards (MPS) of the related Federal Aviation Administration (FAA) technical standard order (TSO) approval, but not the approved type design. Where an affected restraint does not hold TSO, they also meet their defined minimum performance standard, but not the approved type design.

- b. Look in the slot (Figure 2) at the bottom of the buckle's release button where the connector is inserted when wearing the restraint system. If necessary, tilt the buckle at a slight angle.

- c. Look for the groove pin. The groove pin is easily distinguished from other components within the buckle because it is a bright, stainless steel bar that is positioned in front of all other components.
- d. If a groove pin is observed in the slot no further action is required. Complete and return the notice of service bulletin compliance on the last page of this service bulletin.
- e. If a groove pin is not observed perform the following steps for restraints that begin with P/N 2291, 3184, 3279 and 3313.

- i. Remove the affected restraint following the removal instructions in the maintenance manual (Table 2).

- ii. Return the affected restraint to AmSafe following the instructions in section 2.1 for an expedited repair.
 - iii. Obtain an interim restraint following the instructions in section 2.1. Install the interim restraint following the replacement instructions in the maintenance manual (Table 2).
NOTE: Use of an interim restraint is optional.
NOTE: AmSafe will expedite repair/rework and return the affected restraint.

- iv. Upon receiving the reworked restraint, remove the interim restraint (if used) following the removal instructions in the maintenance manual (Table 2). Return the interim restraint to AmSafe following the instructions in section 2.1.

- v. Install the reworked restraint following the replacement instructions in the maintenance manual (Table 2).
 - vi. Complete and return the notice of service bulletin compliance on the last page of this service bulletin.
