SERVICE BULLETIN

Missing Groove Pin in End-Release Buckle

All Aircraft Types Affected

SB504744, Issue: 4
Page: 1 of 13
Date: 24-Apr-2019

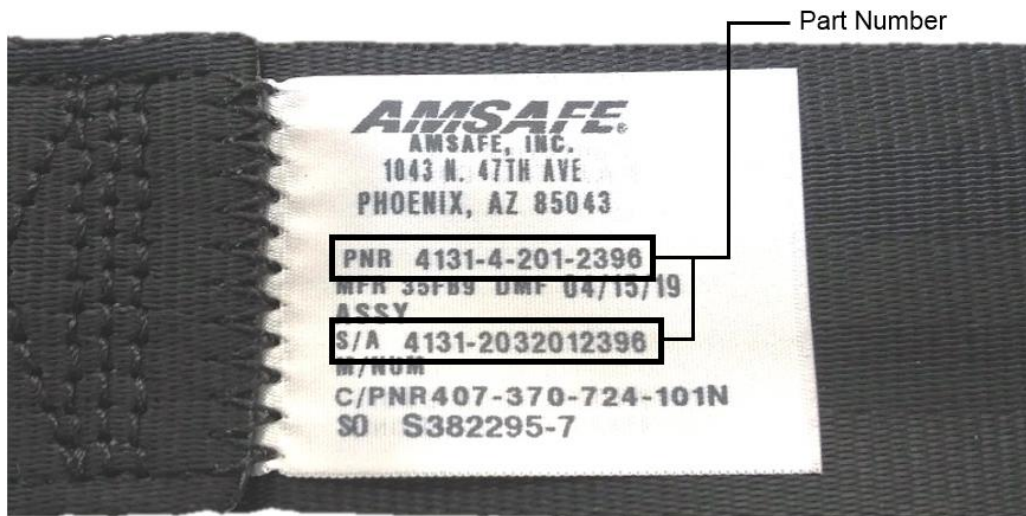
Figure 1 – Representative Label

1. Find the restraint P/N. P/Ns are located on a label on the restraint (Figure 1).

2. If the P/N is not listed in Table 1 no further action is required. Complete and return the notice of service bulletin compliance on the last page of this service bulletin.
3. If the P/N is listed in Table 1 look for a groove pin.
 - a. Access the buckle half.

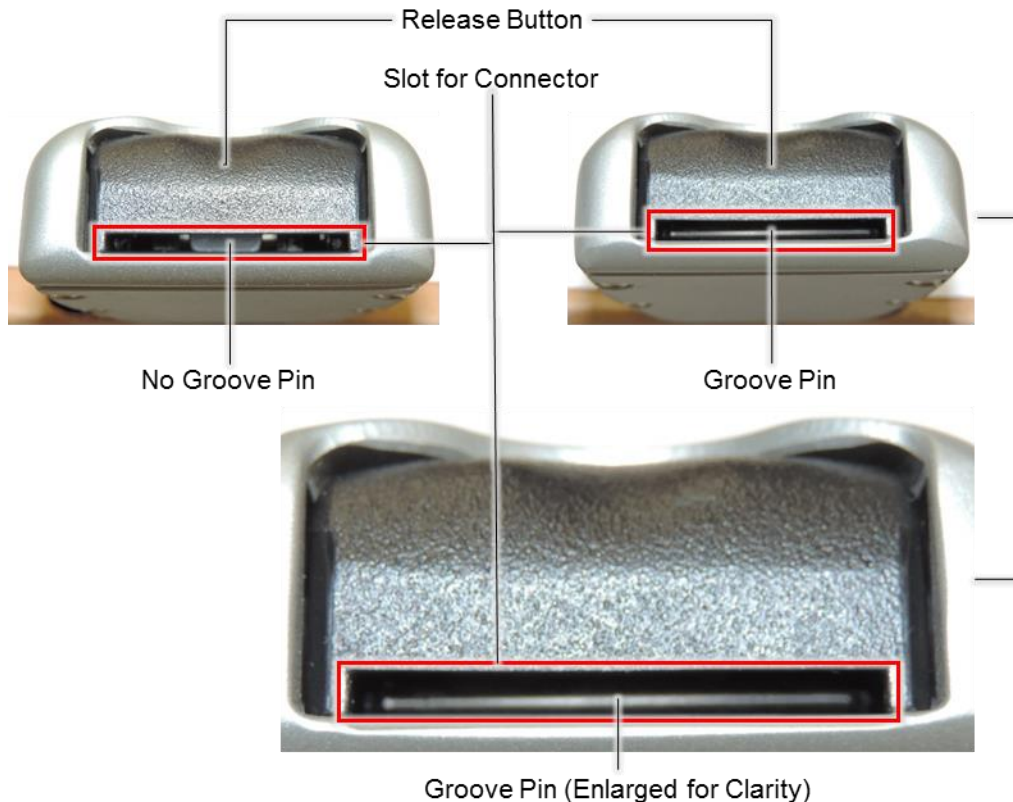
Figure 2 – Buckle and Groove Pin

- b. Look in the slot (Figure 2) at the bottom of the buckle's release button where the connector is inserted when wearing the restraint system. If necessary, tilt the buckle at a slight angle.

- c. Look for the groove pin. The groove pin is easily distinguished from other components within the buckle because it is a bright, stainless steel bar that is positioned in front of all other components.
- d. If a groove pin is observed in the slot no further action is required. Complete and return the notice of service bulletin compliance on the last page of this service bulletin.
- e. If a groove pin is not observed perform the following steps for restraints that begin with P/N 2291, 3184, 3279 and 3313.

- i. Remove the affected restraint following the removal instructions in the maintenance manual (Table 2).

- ii. Return the affected restraint to AmSafe following the instructions in section 2.1 for an expedited repair.
- iii. Obtain an interim restraint following the instructions in section 2.1. Install the interim restraint following the replacement instructions in the maintenance manual (Table 2).
NOTE: Use of an interim restraint is optional.
NOTE: AmSafe will expedite repair/rework and return the affected restraint.

- iv. Upon receiving the reworked restraint, remove the interim restraint (if used) following the removal instructions in the maintenance manual (Table 2). Return the interim restraint to AmSafe following the instructions in section 2.1.

- v. Install the reworked restraint following the replacement instructions in the maintenance manual (Table 2).
- vi. Complete and return the notice of service bulletin compliance on the last page of this service bulletin.
