Sliding Carpet Repair for Commercial Aviation Aircraft

By: Stephen Hancock
Development Director
Airframe Products

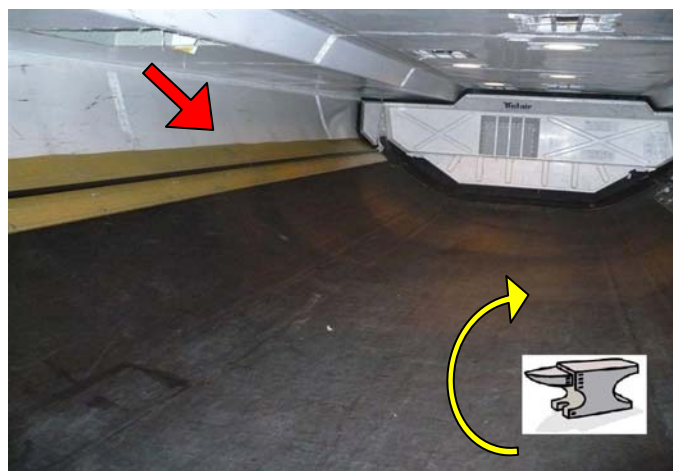
If the luggage is not loaded properly and the weight of the bags is not evenly distributed across the width of the carpet, a condition called a "point load" may occur. Using the illustration below, if a heavy load were placed on the carpet (identified by the anvil), the carpet would not pull evenly and it would tend to rotate (identified by the yellow arrow). This rotation creates high stress points (large red arrow) on the edge of the carpet. This stress may result in damage to the guide rails or the urethane profile being torn from edge of the carpet.

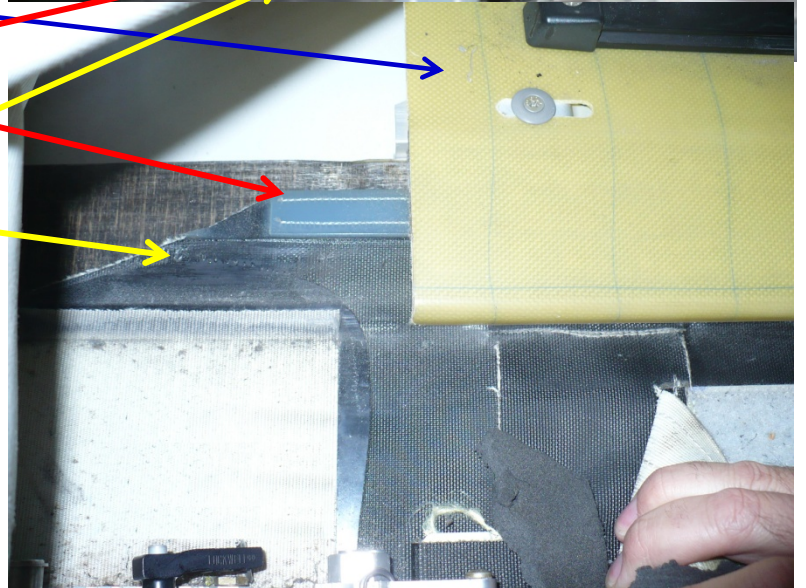
Fig. C: Carpet

The profile (identified below, Fig. B) slides back and forth in a guiderail. Unbalanced loading occurs when heavier objects are not evenly distributed across the width of the carpet which may result in the carpet pulling out of the guide rail and causing damage to either the guiderail, carpet or both (identified below, Fig. C)

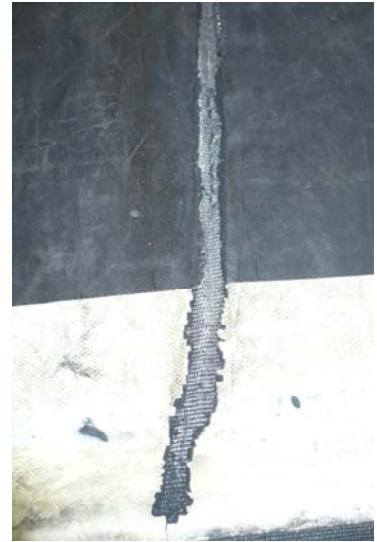
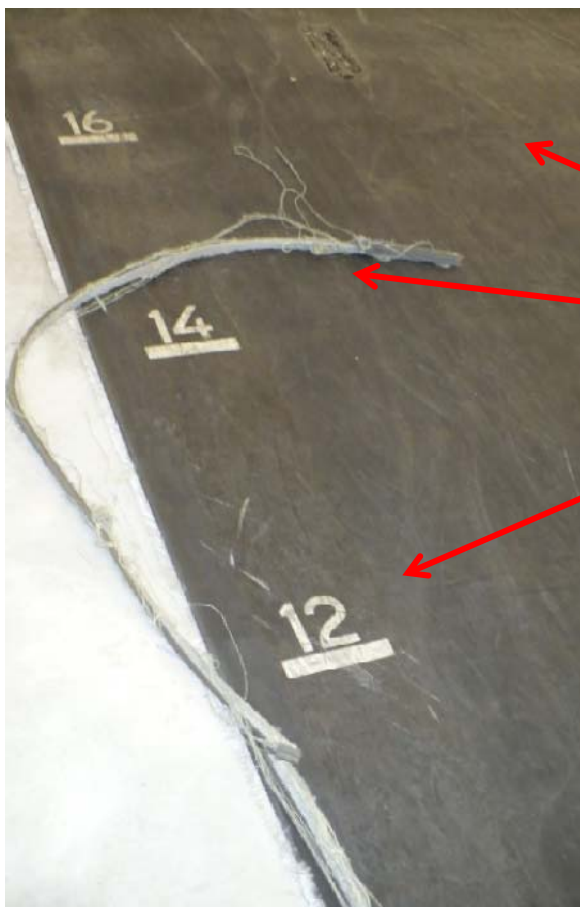
- **Urethane coating removal.** This is considered cosmetic damage and does not hinder the operation of the system. This damage is caused by articles (items that have fallen off of damaged luggage or other foreign matter) being wedged between the carpet and the sliding carpet structure scraping off the top urethane layer. (Pictured on the right.)
- **Carpet position markings.** Markings that have been worn away from use do not affect the operation of the unit. Since the loader stays close to the cargo door, once the first few rows of bags are used the loader is not able to easily determine how much available space remains in the cargo hold. Refreshing the markings on the repaired carpets is critical efficient loading and operation of the systems.
- **Urethane profile tears off.** The damage to the carpet occurs when the profile is ripped from the edge of the carpet. (Pictured below.)

Carpet
Torn urethane profile
Markings

AmSafe has developed a repair procedure that will return a carpet to a serviceable condition as long as the carpet is used within the OEM's operating parameters. The AmSafe repair and overhaul service will significantly reducing the cost of ownership as the carpet can now be repaired versus replaced.

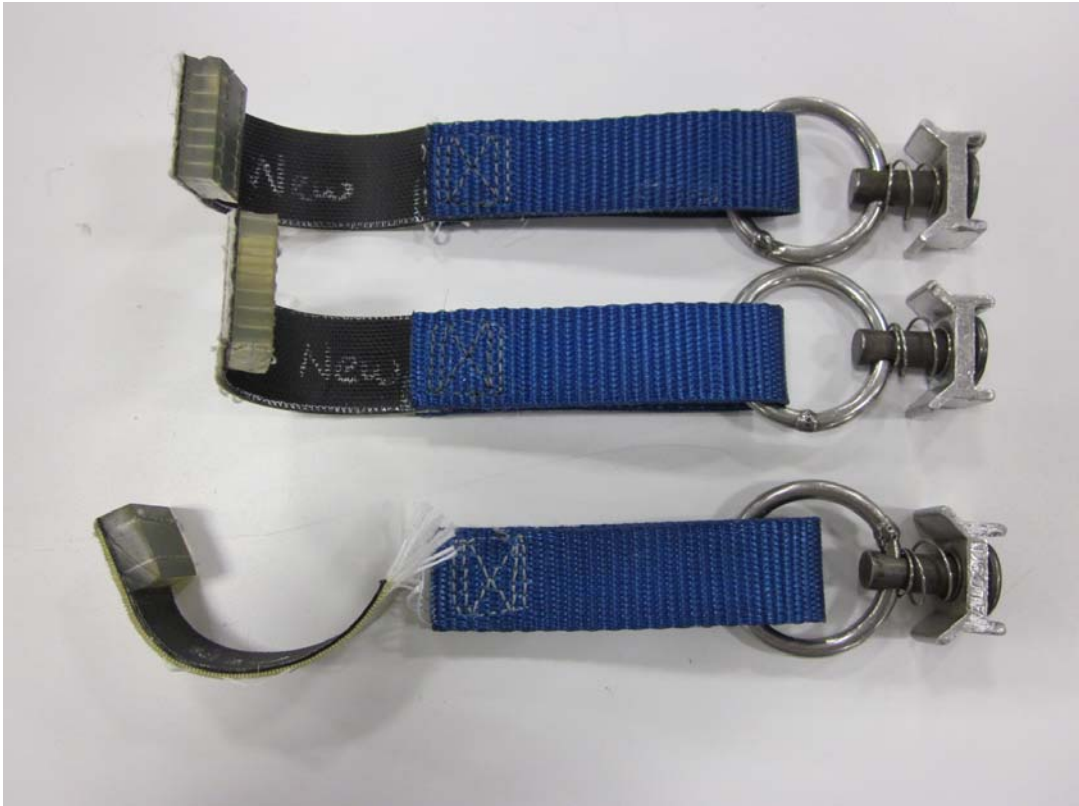
New samples after testing.

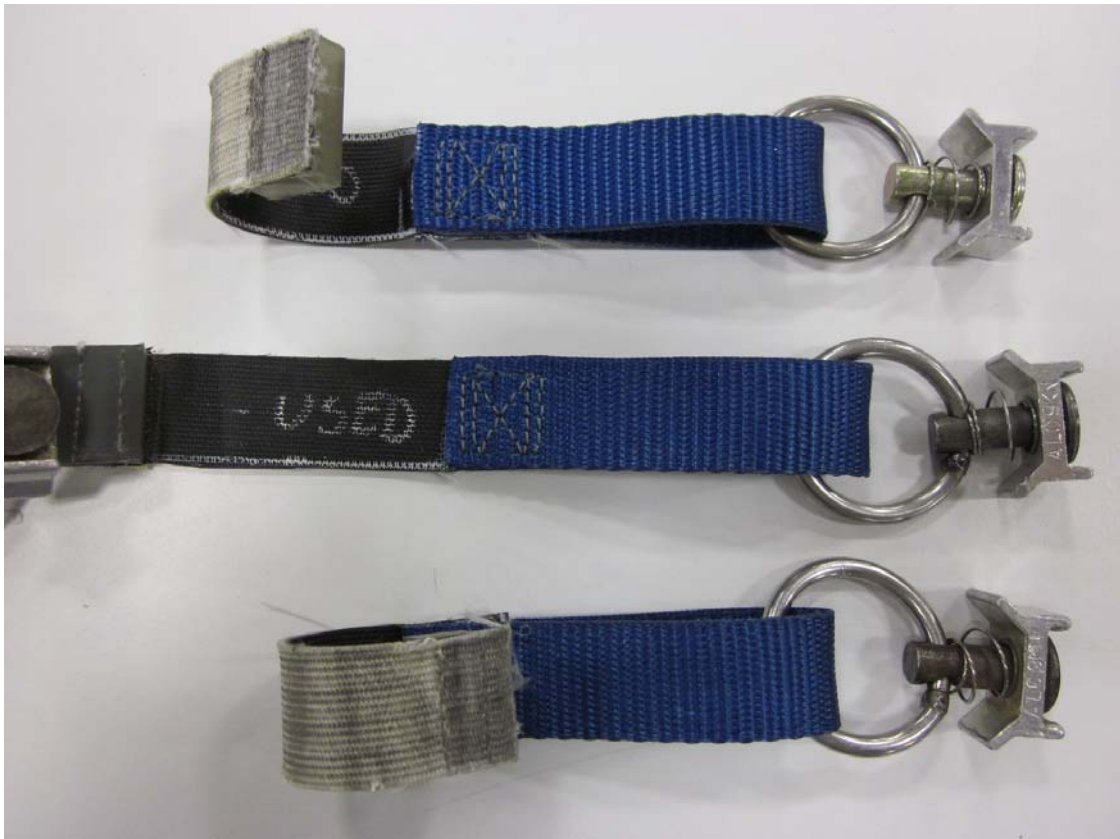
Used samples after testing.

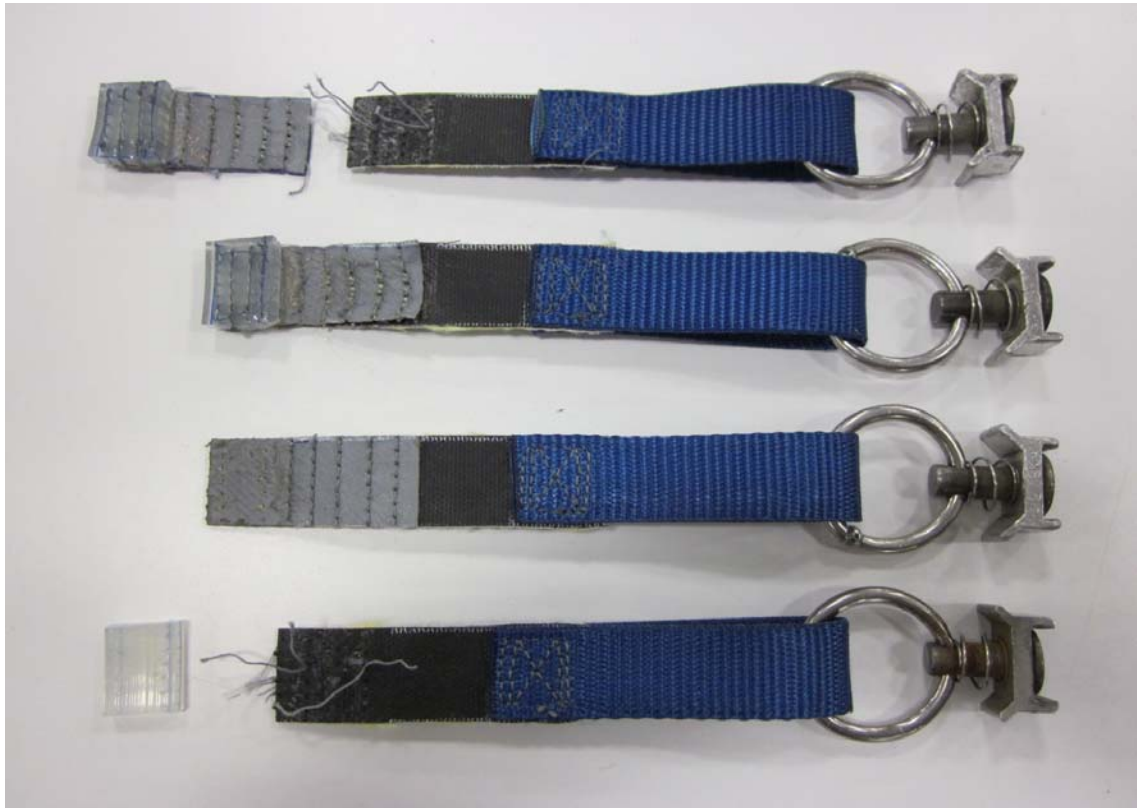
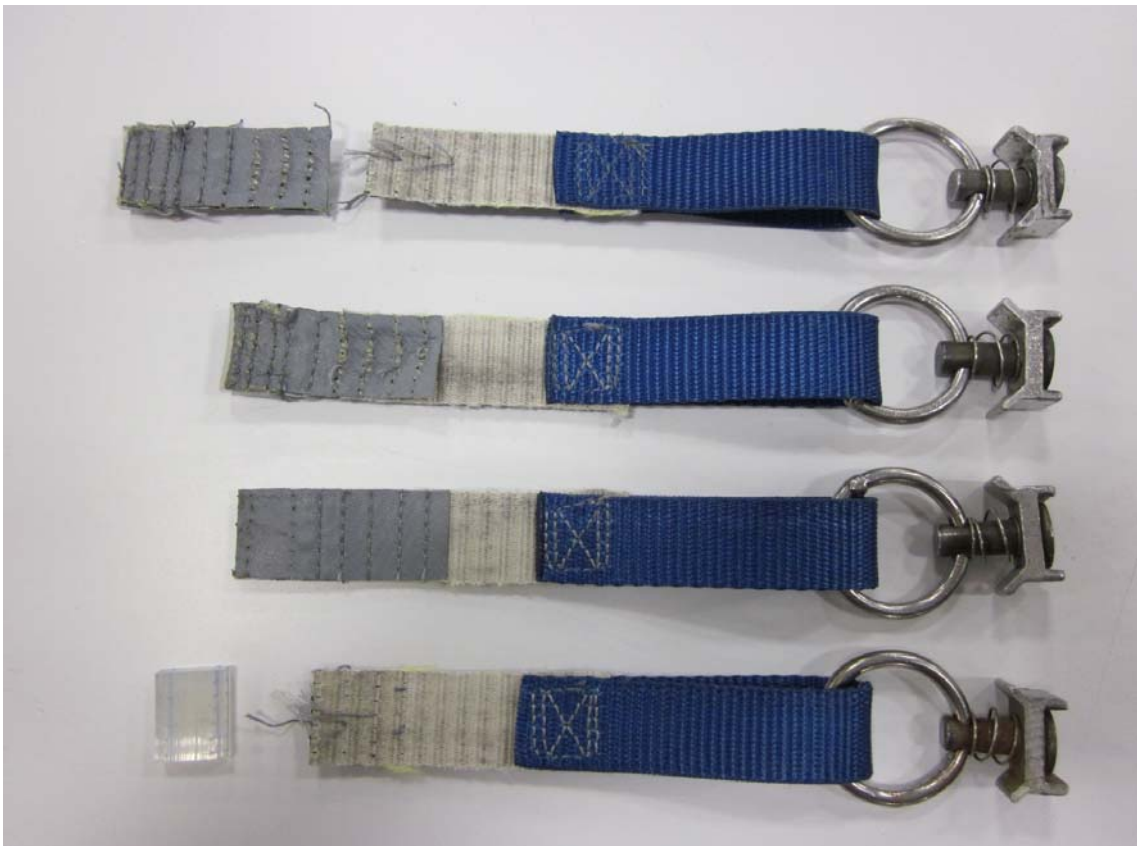
Testing samples of carpet subject to one repair.

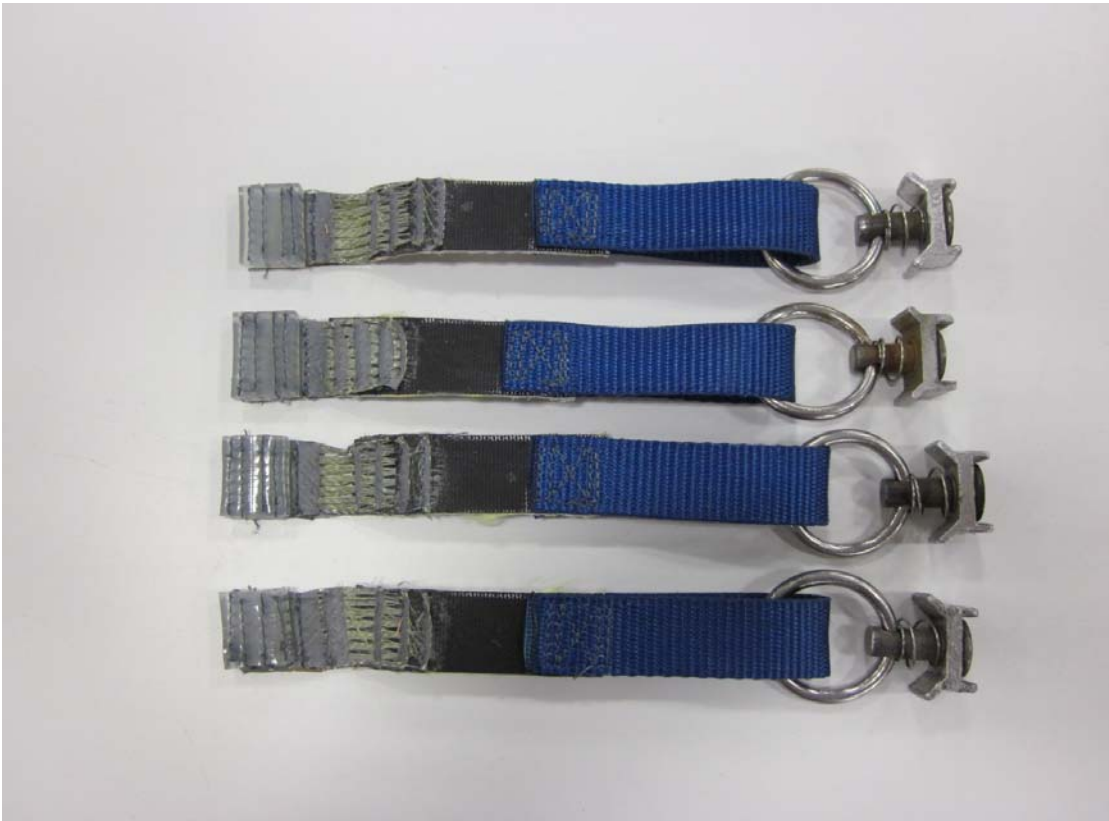
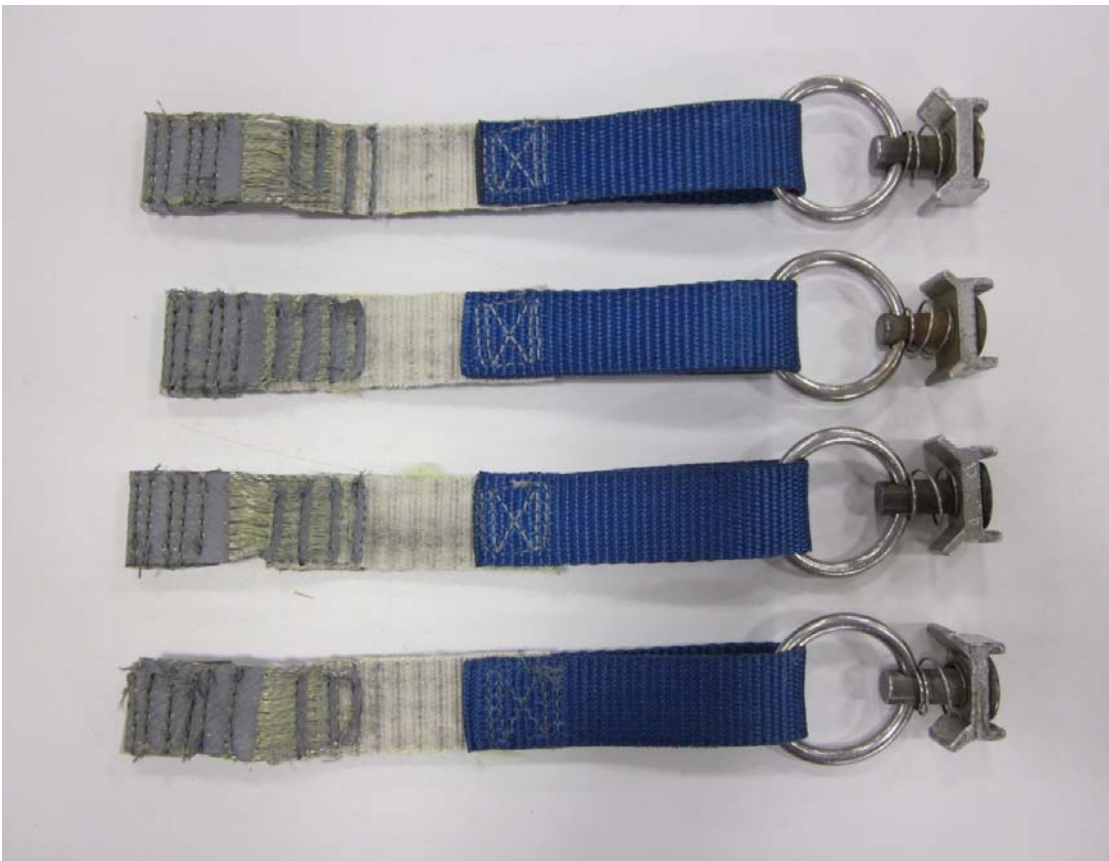
Test samples of carpet subject to two repairs.
