# AmSafe Under Floor Cargo Nets

Unsafe Flying Conditions

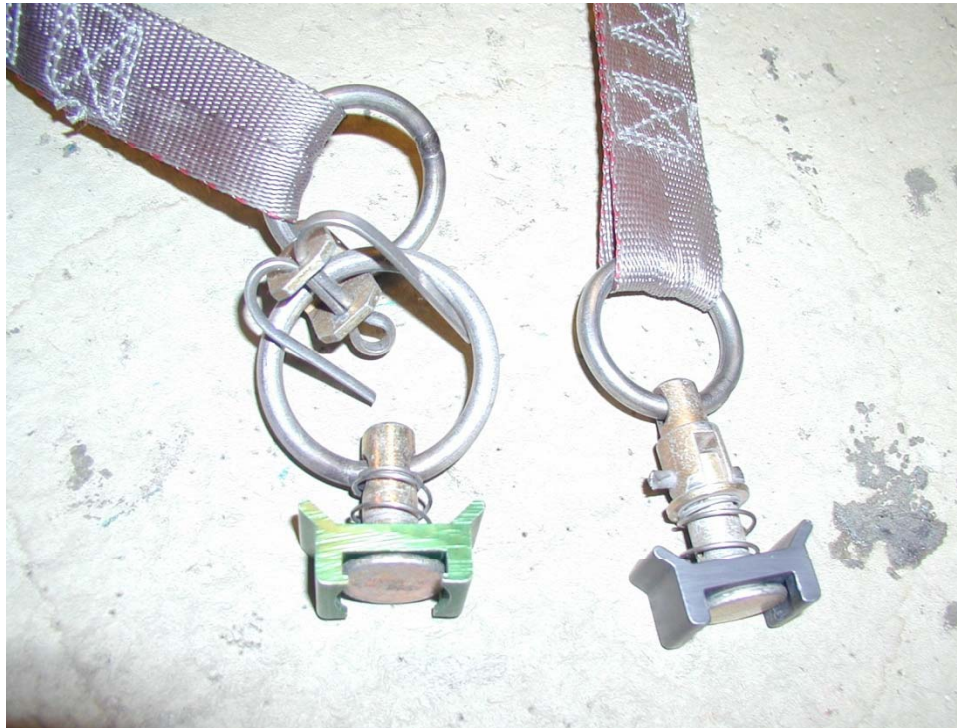
# Makeshift Fitting

The breakaway fitting on the left was repaired using a standard single stud and a split pin. The original fitting (right) is designed to break at a specified load to prevent damage to the airframe. This controlled failure may not occur if the repaired fitting is stronger than the original.

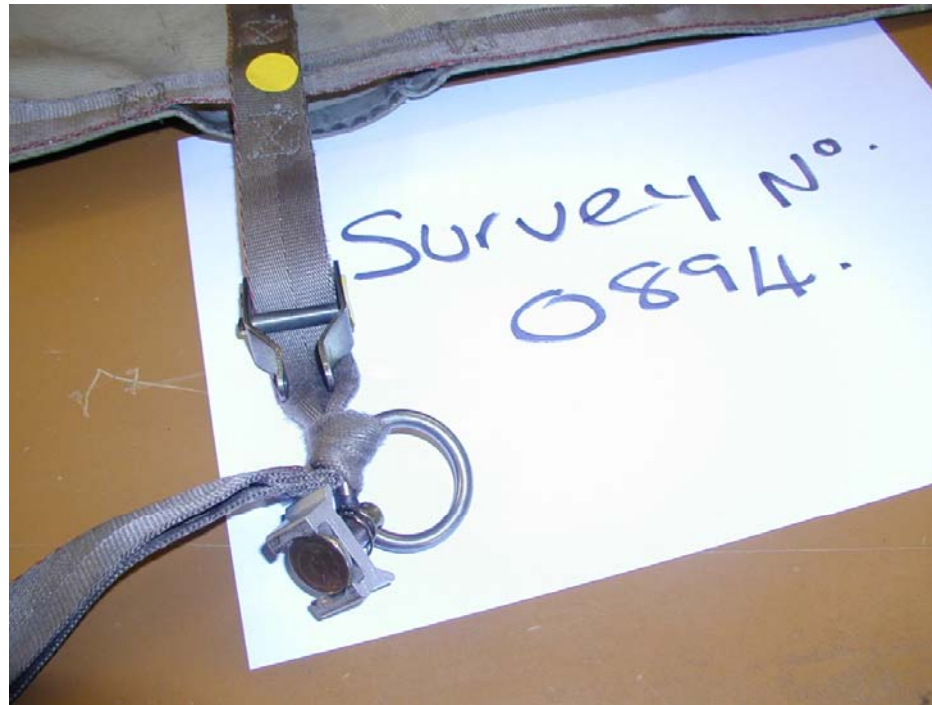
## Single Stud Tied On

This picture shows a single stud which has been tied on in place of an adjustment buckle. Tying a knot in webbing reduces its strength by typically 50%. In addition the net cannot be adjusted to its optimum tension; therefore, the load distribution on the net has changed which could result in catastrophic failure of the equipment.

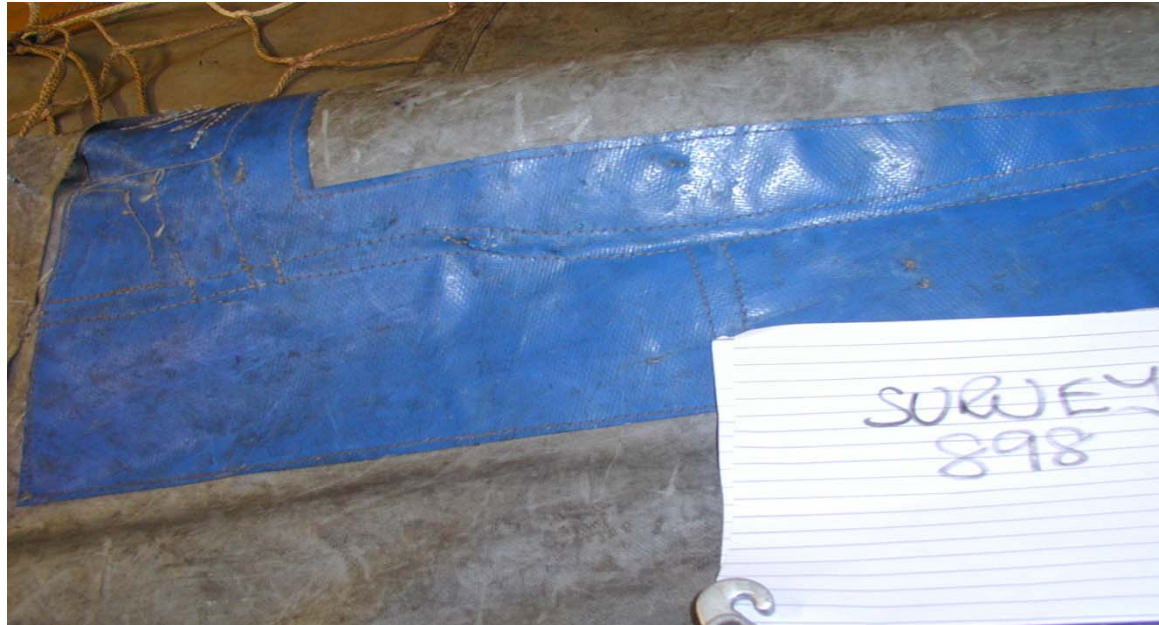
# Illegal Parts

The grey fabric in this photograph is the correct specification and meets all design parameters including strength, flammability, smoke and toxicity. The blue fabric is part of an illegal repair, i.e. not in accordance with the equipment CMM as the repair uses the wrong material and the wrong repair method.

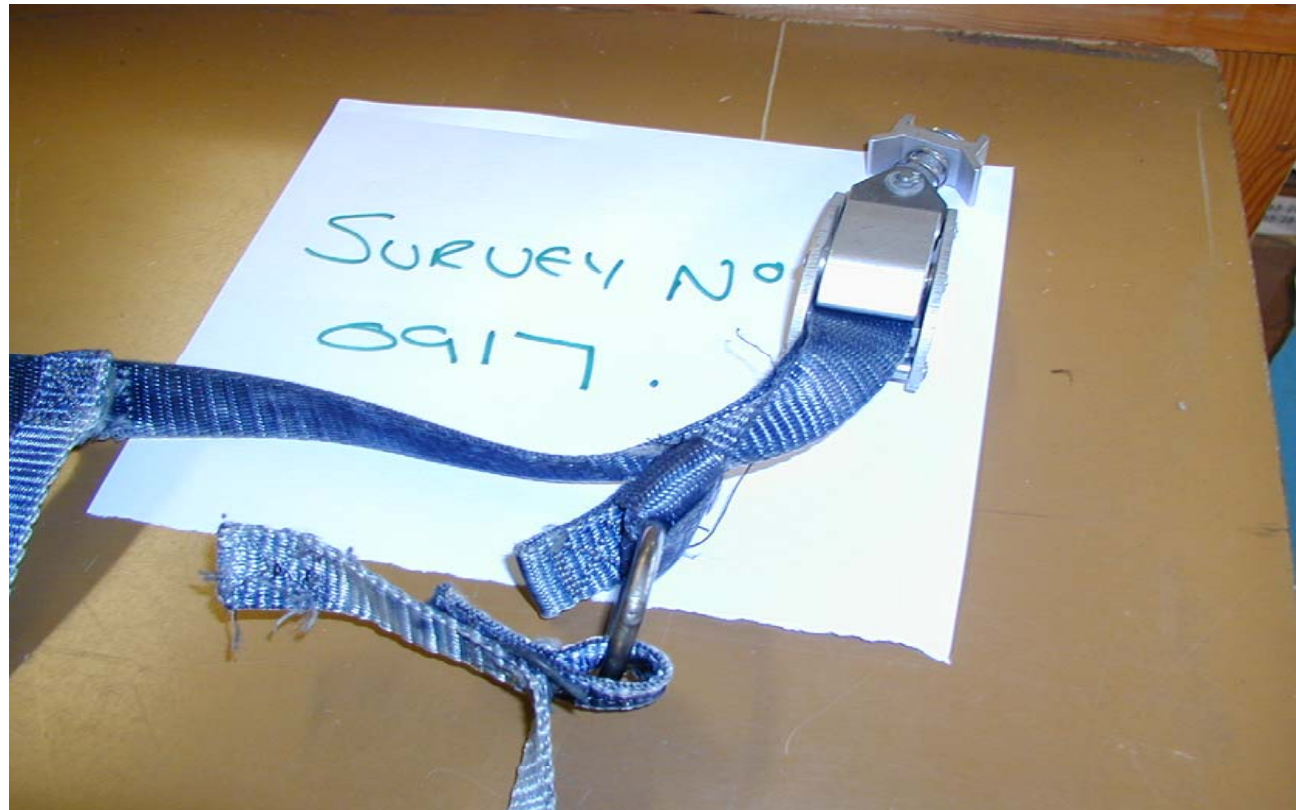
# Illegal Webbing Repair

This photo shows how a steel ring has been used to join a broken vertical webbing element to the top horizontal web. It has been joined by tying the vertical element to the adjustable hand pull. Again, this will affect the load distribution and could result in catastrophic failure.

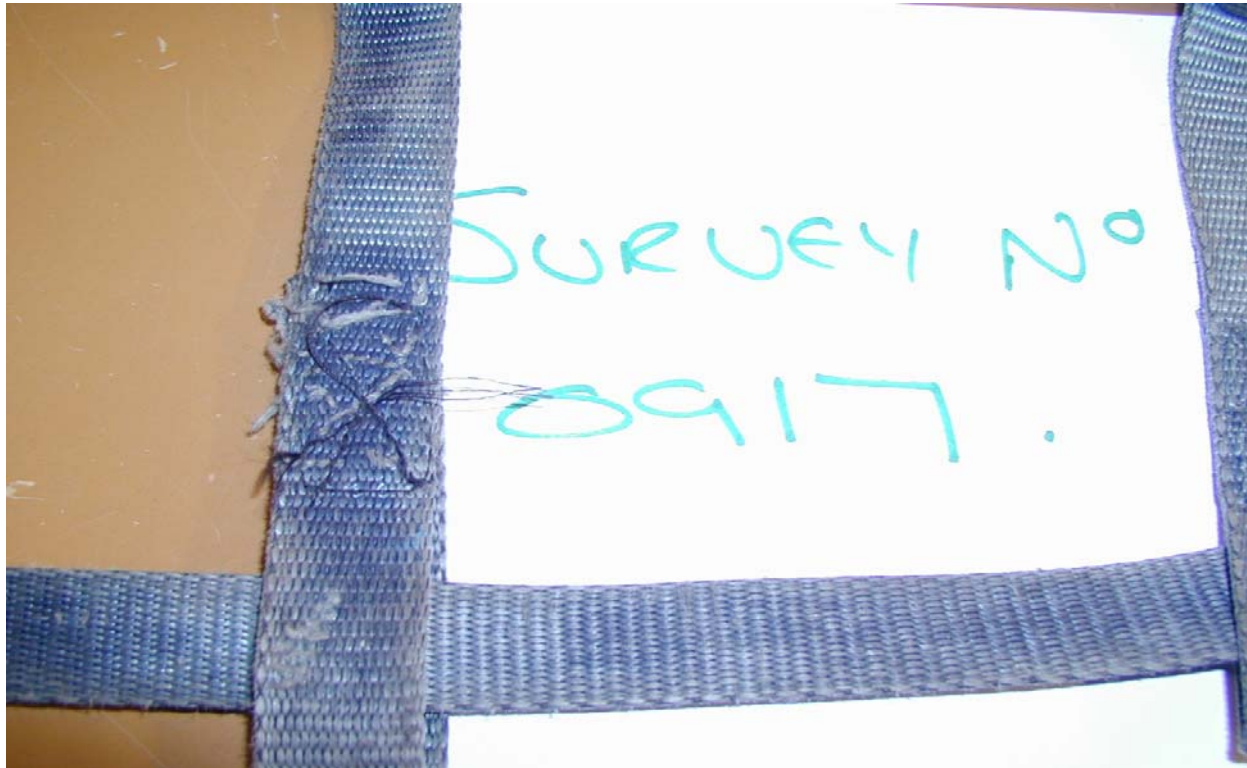
# Hand Stitch Repair

In this photo the webbing is broken at the stitched intersection and has been repaired with a hand stitch. The structural integrity of this net may be severely compromised.

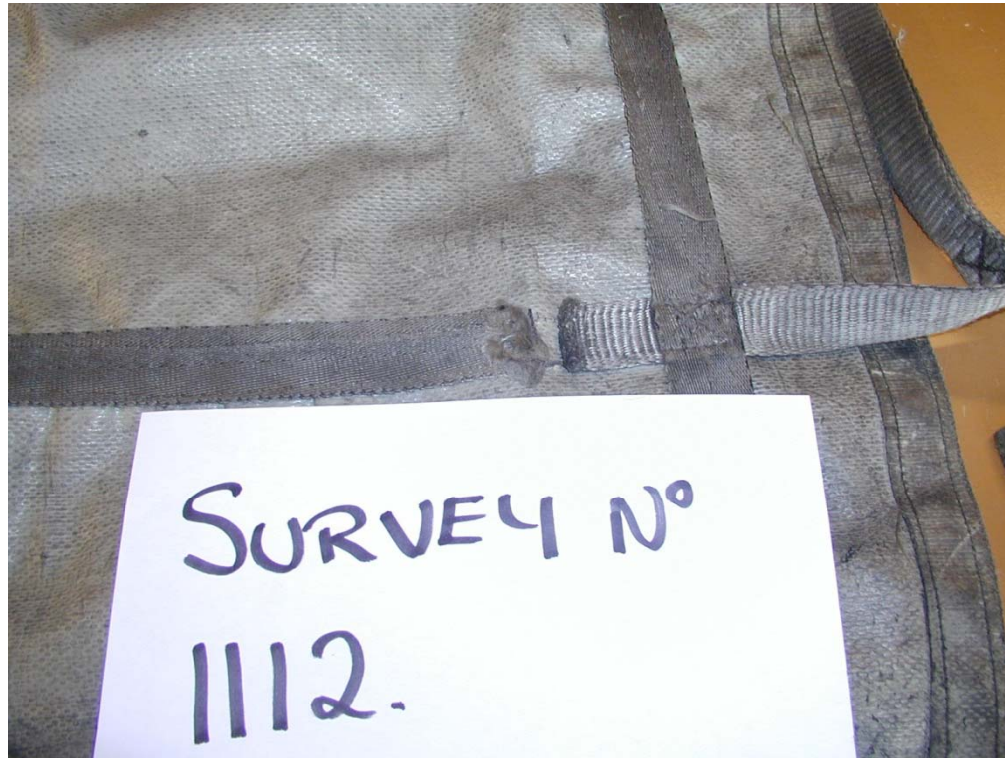
# Illegal Webbing Repair

Here, broken webbing has been repaired by simply sewing it to the fabric cover; this renders the net unfit for purpose.

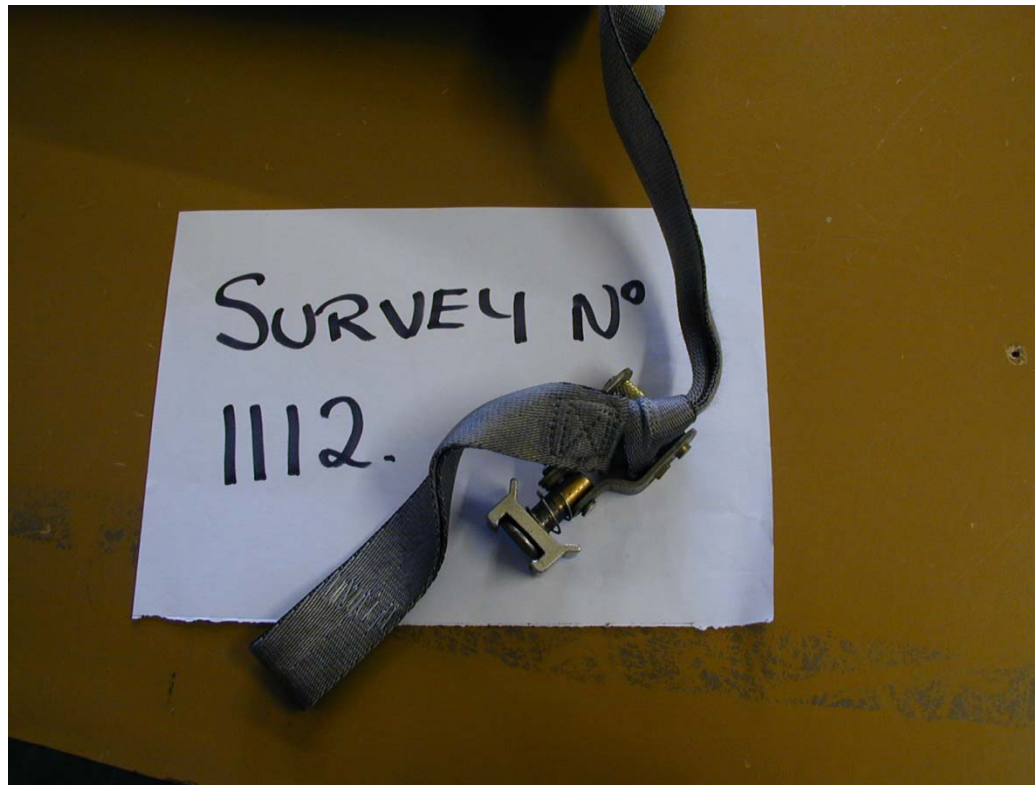
# Broken Fitting Tied On

In this photo, a broken breakaway fitting has been tied on losing the ability to adjust the net. This may change the dynamics of the net when loaded potentially causing airframe damage

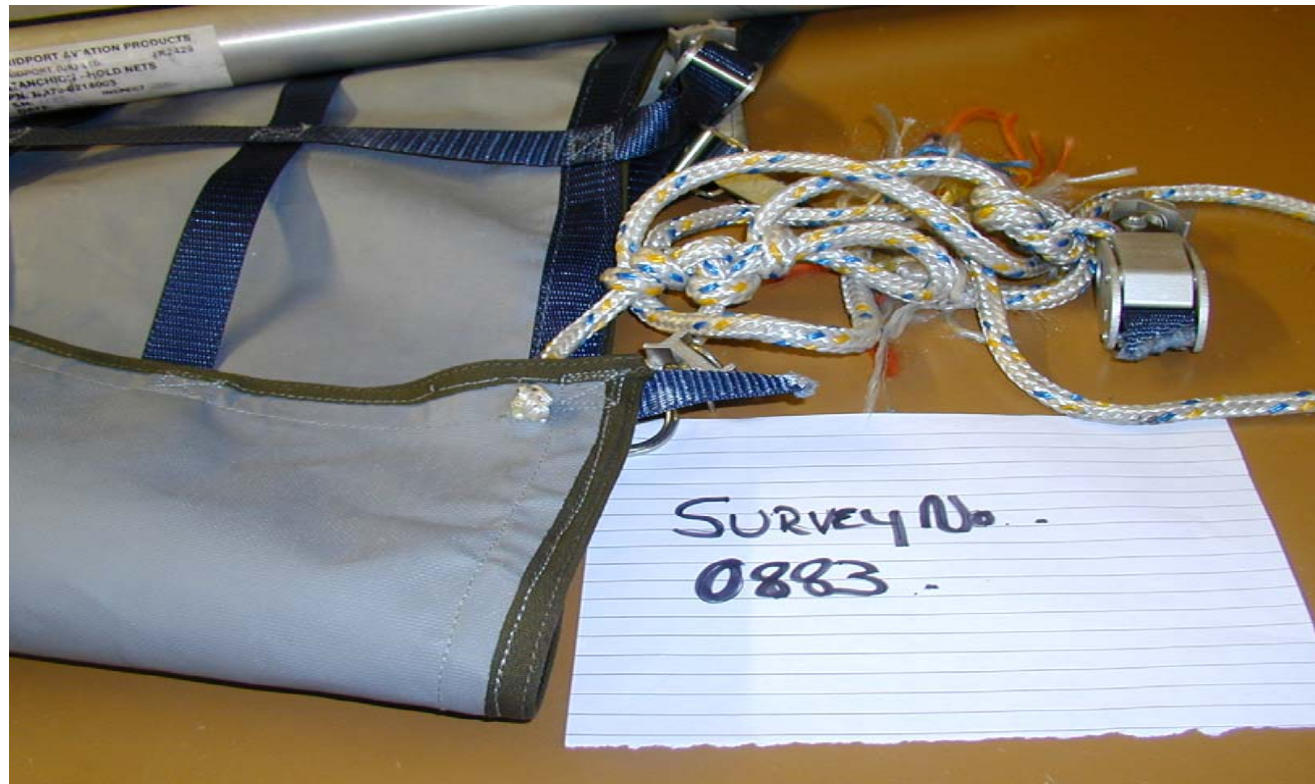
# Ropey Repair

In this picture you can see how a length of rope has been used to tie on a cam buckle.

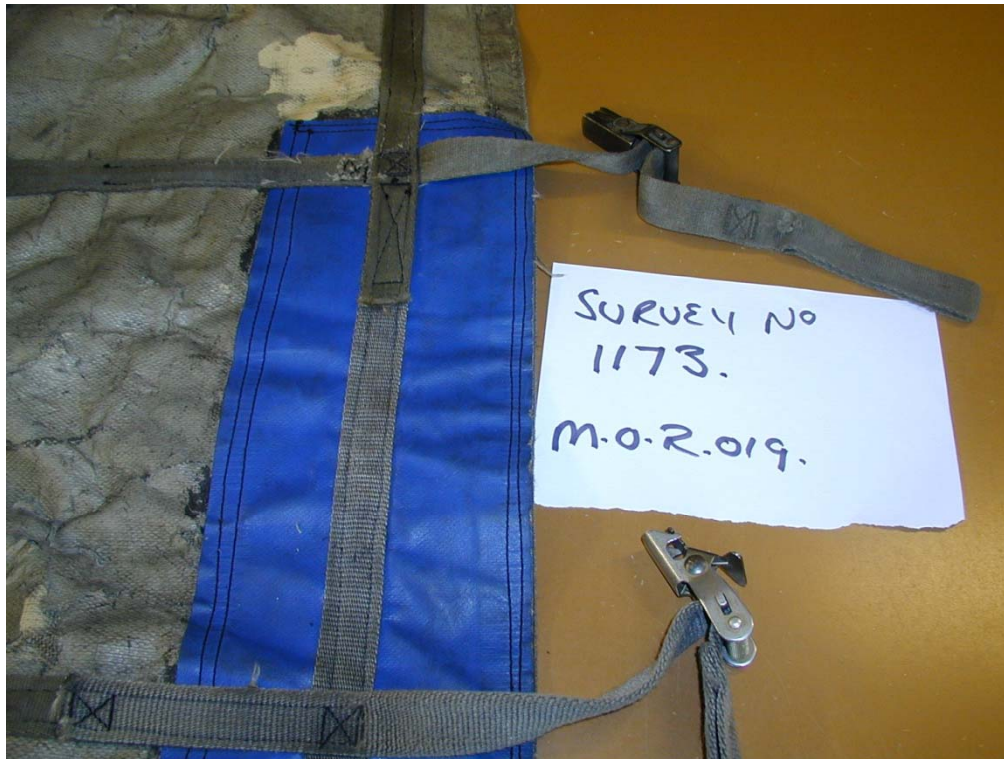
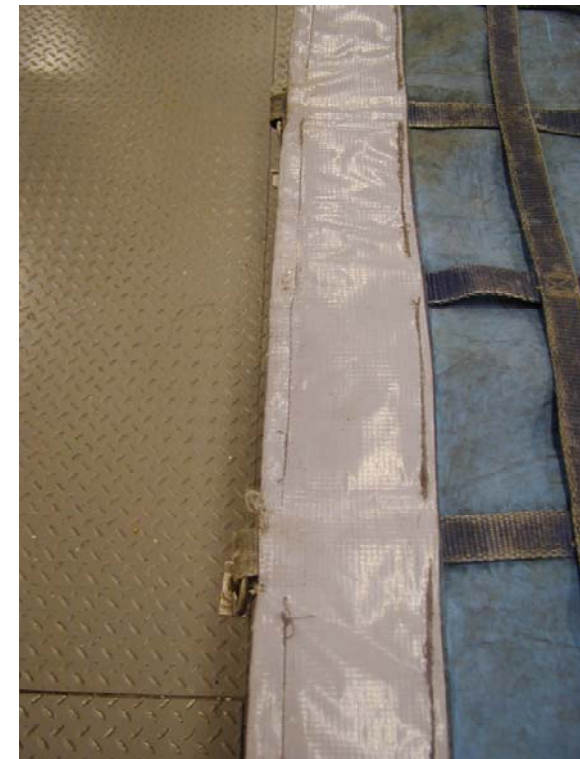
# Wrong Fabric

More examples of the wrong fabric being used to carry out repairs. In both cases the method of repair does not meet the requirements of the CMM.

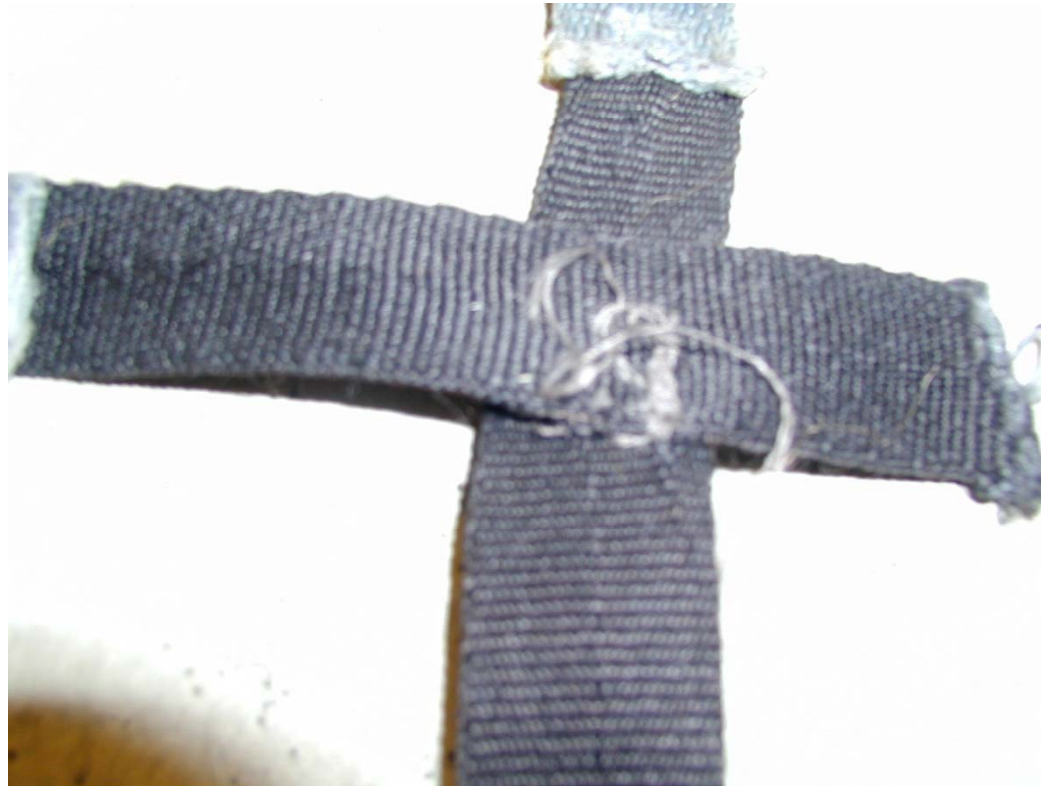
# Illegal Repair

Here, the stitching has failed on a repair carried out using the wrong method and the wrong material. The strength of both the horizontal and vertical elements have been adversely affected.

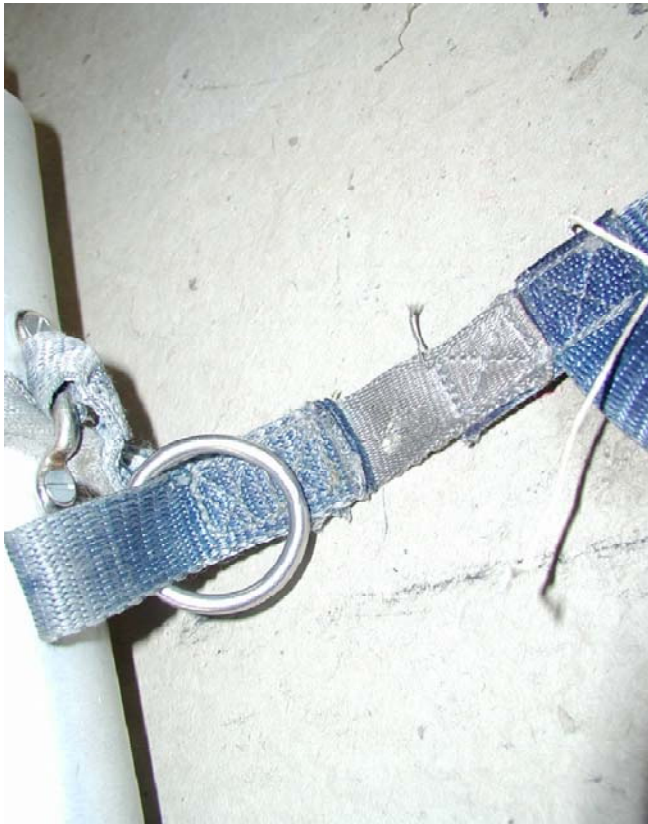
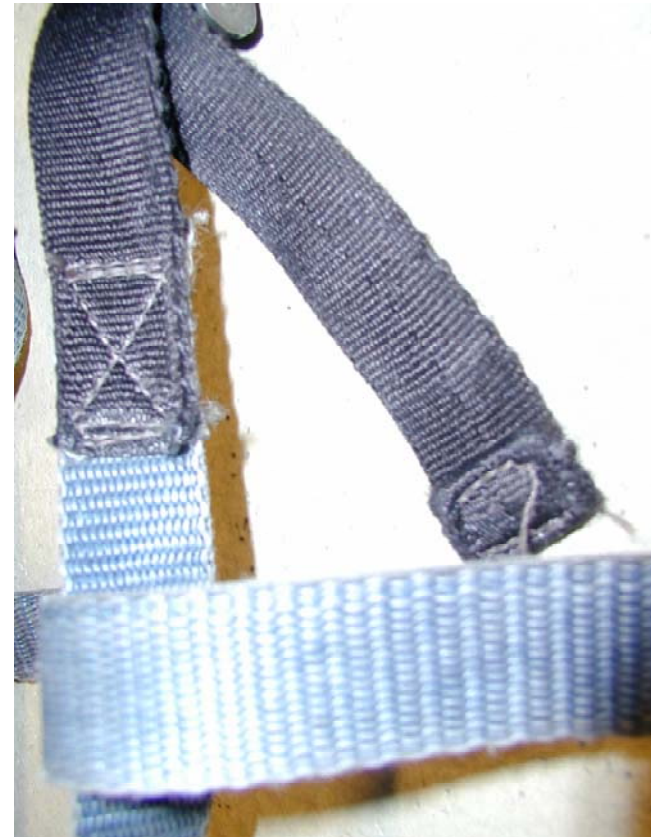
## Incorrect Materials/Methods

The grey webbing in this photograph is made of a lower strength than the original supplied with the net. The method of attachment is incorrect and the strength of the net has been reduced in several places.

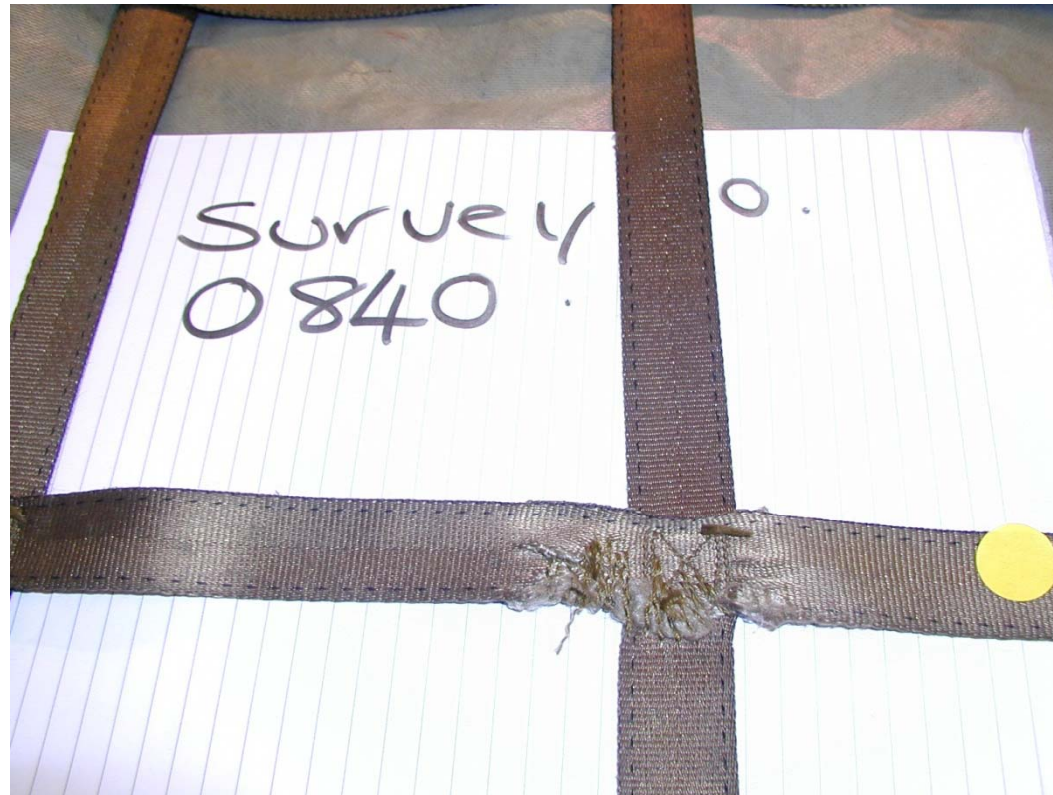
# Darned Nets

The webbing is cut and badly frayed and in this example, it has been repaired by darning the frayed edges by hand. This intersection is severely weakened and will not function correctly under load.

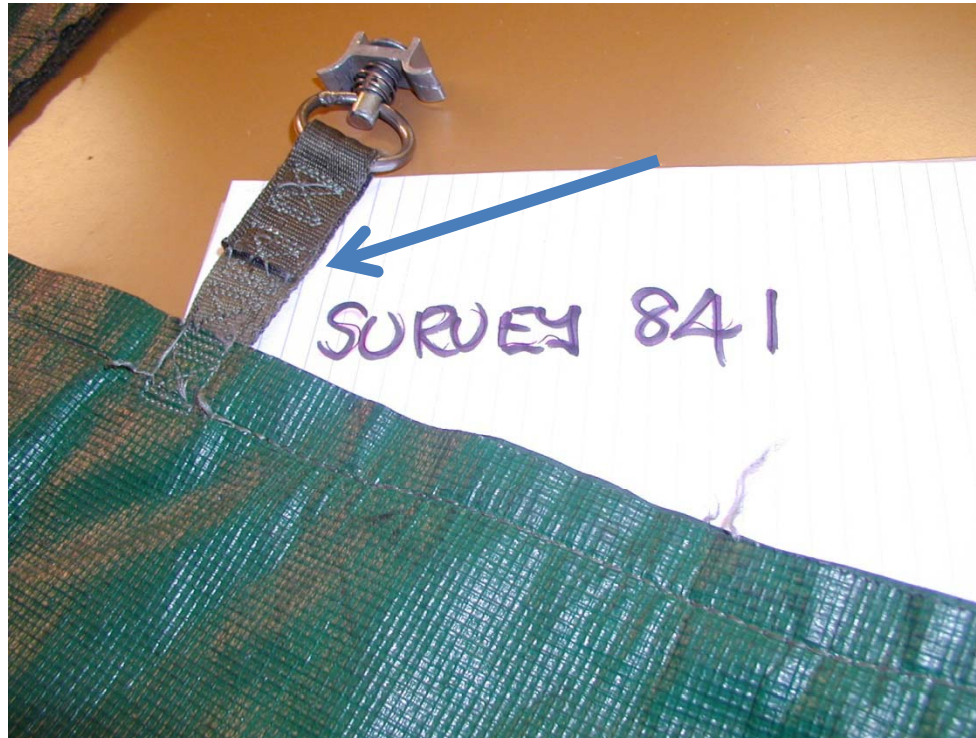
# Poor Sewing

The stitch pattern highlighted runs off the edge of the webbing thus severely weakening the vertical strap.

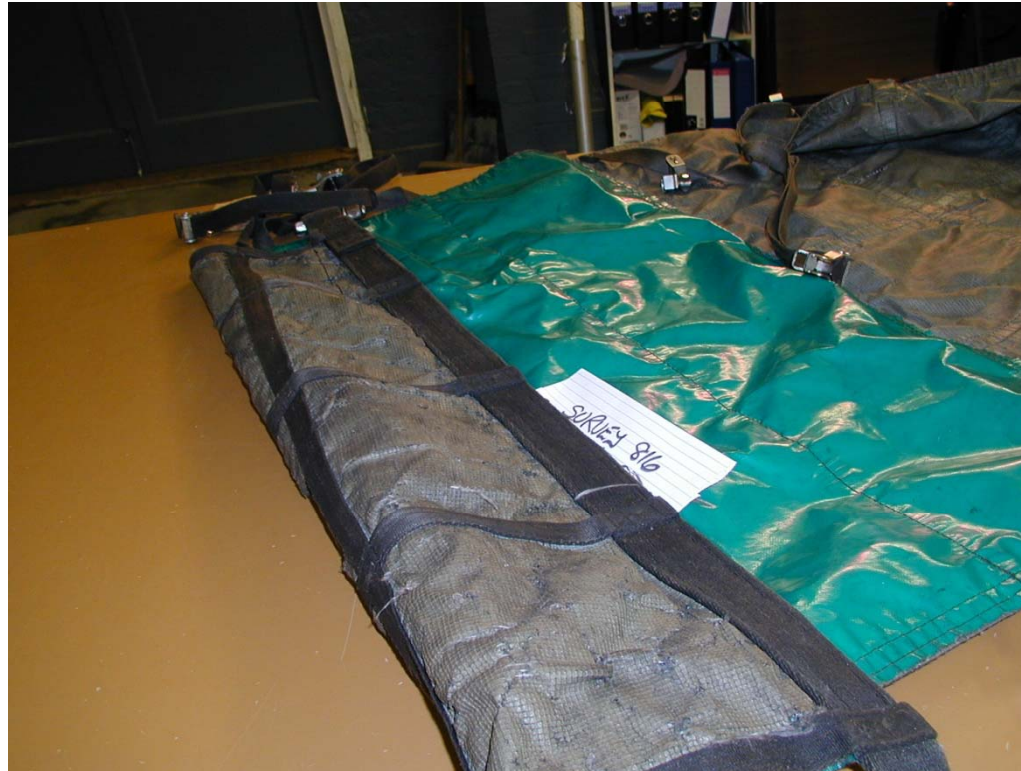
## More Illegal Repairs

The green fabric has been sewn onto one side of the net to cover up rips in the original fabric. The weight of the net has been increased significantly increasing fuel consumption. Importantly, the fabric used for the repair is not identified and not specified in the CMM.
