SERVICE BULLETIN

Equipment/Furnishings
Passenger Compartment

Inspection, Check and Replacement of Hook
Assembly P/Ns 505960-401 and 502737-459

SB505960-01, Issue: 4
Page: 1 of 13
Date: 12-Jul-2018

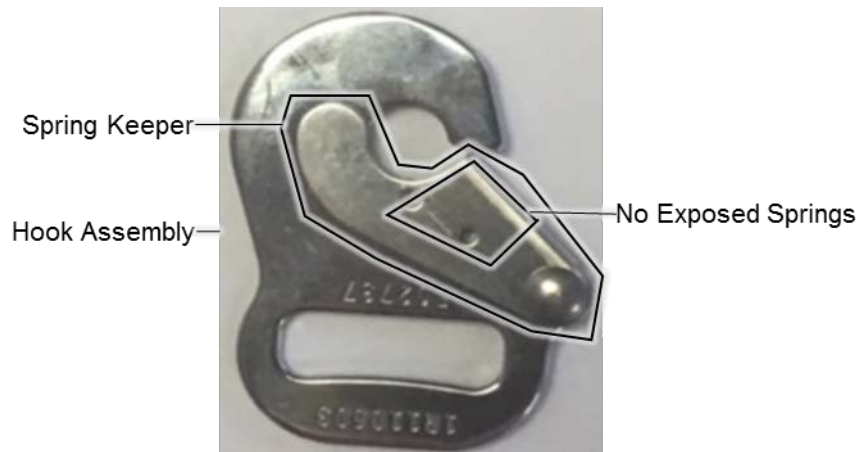
Figure 1 – Hook Assembly Without Exposed Springs

Step a. If the hook assembly on the connector half and the buckle half does not have exposed springs (Figure 1) you are done with this service bulletin.

Restraints without exposed springs (Figure 1) weigh 6 grams more than restraints with exposed springs (Figure 2).

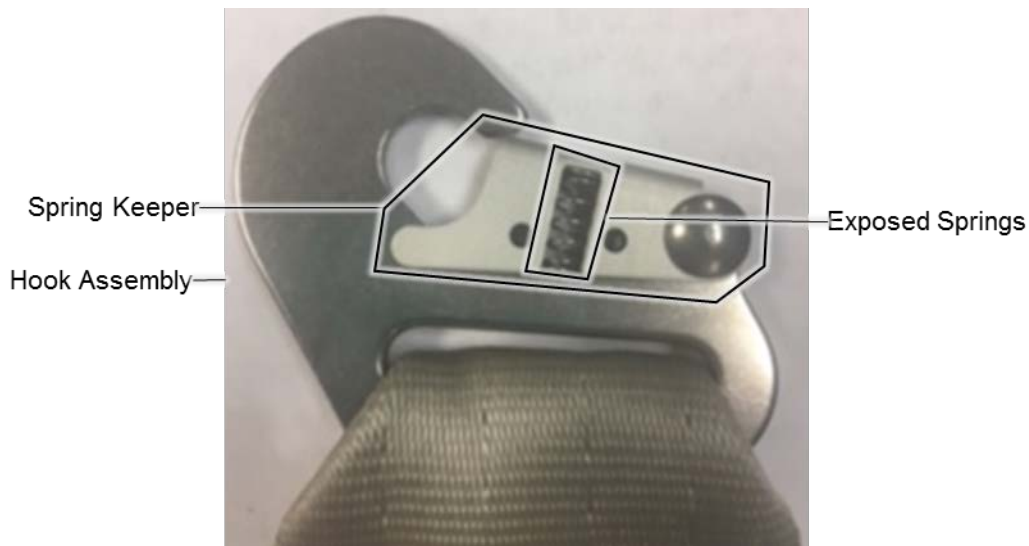
Figure 2 – Hook Assembly With Exposed Springs

Step b. If the hook assembly has exposed springs (Figure 2) proceed with this service bulletin.

Hook assemblies with exposed springs are subject to damage (e.g. compressed springs, bends or rotation or deformation).

Interchanging or intermixing restraints is not allowed. Restraints with exposed springs on the hook assembly must be returned to AmSafe.

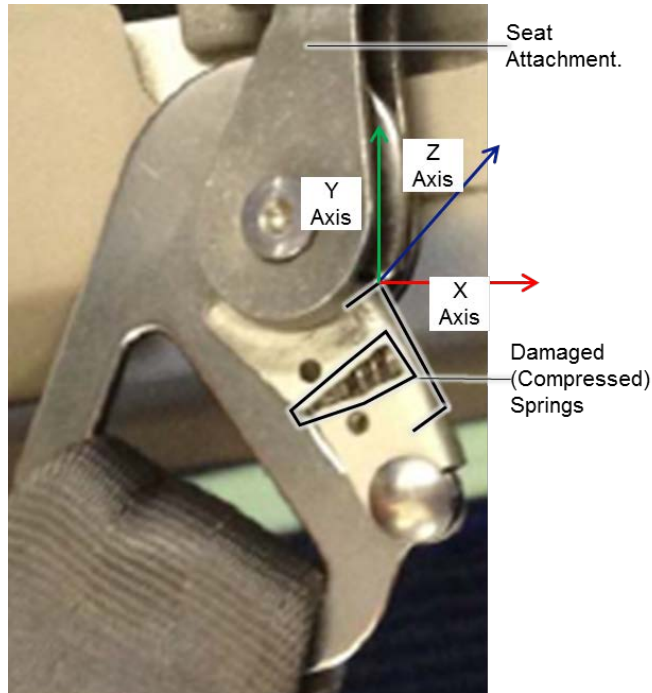
Figure 3 – Damaged Hook Assembly

RC Step 2. Visually examine the hook assembly for damage (e.g., compressed springs, bends, rotation or deformation of the bridge along the X axis, Y axis or Z axis) that would restrict movement or function (Figure 3 and Figure 4).

Step b. If there is evidence of damage a functional check is not required.

Step i. Return the restraint to AmSafe by following the instructions in the material – price and availability section of this service bulletin and by following the instructions in the shipping and handling instructions in the ICA or CMM.

Step ii. Upon receipt of a new restraint from AmSafe, install the new restraint following the instructions in the ICA or CMM.

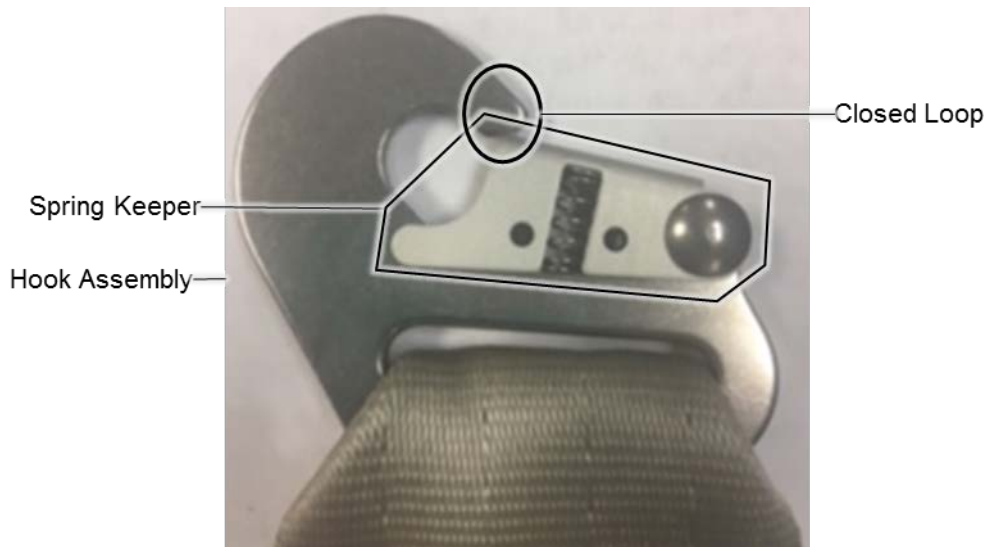
Figure 5 – Spring Keeper and Closed Loop

Step b. The spring keeper should return to a closed position. The closed position is achieved when the spring is firmly engaged/pressed and the keeper is against the hook, creating “closed loop” (Figure 5). There should be no deformation or damage preventing the spring keeper from returning to a closed position.

- Step c. If the spring keeper easily compresses and releases and returns to the closed position the functional check is complete.
- Step d. If the spring keeper does not easily compress and release, or the spring keeper does not return to a closed position, return the restraint to AmSafe.
- Step i. Return the restraint to AmSafe by following the instructions in the material – price and availability section of this service bulletin and by following the shipping and handling instructions in the ICA or CMM.
- Step ii. Upon receipt of a new restraint from AmSafe, install the new restraint following the instructions in the ICA or CMM.
