SERVICE BULLETIN

INSPECTION / REPLACEMENT OF EJECTOR BASE

ATA 25-20-01

SB504443-25-03, Issue: 2
Page: 1 of 11
Date: 2-Oct-2017

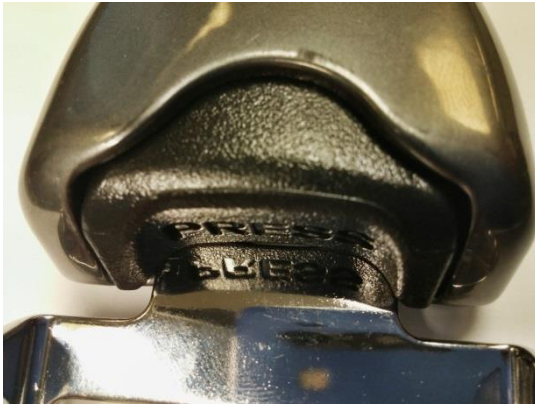
Figure 1: Fully Engaged Connector.

- 3.2 Completely insert the Connector into the Buckle as would be done during normal use. Visually check to see if the Connector is completely engaged within the Buckle. Figure 1 below shows a Buckle where the Connector is fully engaged. Figure 2 shows a Buckle where the Connector is not fully engaged. Notice the opening of the Connector is easily visible in Figure 2, whereas it is not in Figure 1.

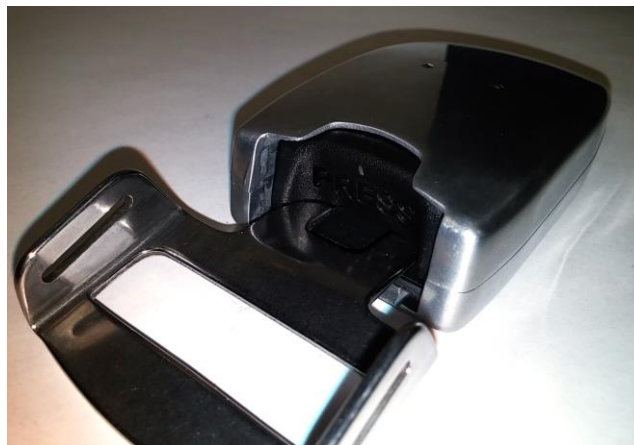
Figure 3: Push Button not Returning when Connector Inserted.

- 3.3 Cycle the buckle fifteen (15) Times. One cycle consists of inserting the connector completely and depressing the Push Button to eject the connector. In the event that the Push Button does not return at all when the Connector is inserted, as seen in Figure 3, proceed with this Service Bulletin by following the directions in Warranty Section 2.7. If the Push Button does return to its resting position, the Buckle is functioning as intended and no further action is required.

By updating the Buckle Assembly with a 504604-11 Ejector Base from current production parts using the latest assembly methodology and fixturing at AmSafe, these issues are resolved.
