WEBBING SERVICE LIFE GUIDELINES

AmSafe, Inc.
1043 N. 47th Avenue
Phoenix, AZ 85043

This document (TR506253) contains proprietary designs, specifications, data, information, and technical material that are the sole property of AmSafe, Inc. to be held and treated by its recipient on confidential basis, and not to be shown or disclosed to any unauthorized organization or person

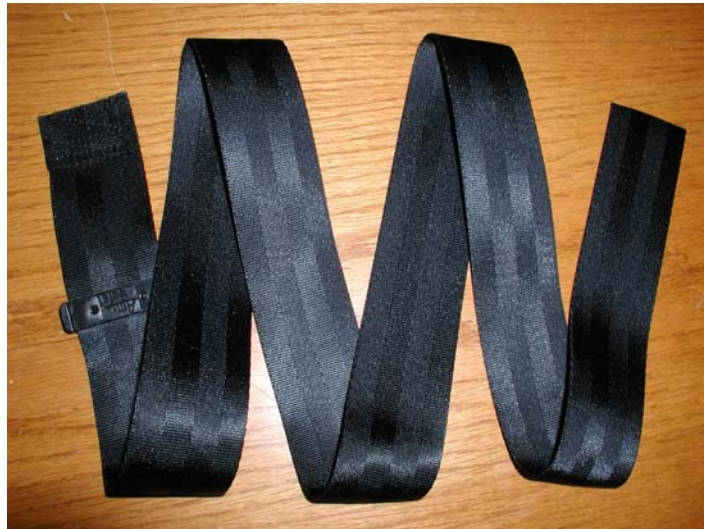
Figure 1: “Looks New” – no visible flaws

Table 1: Visual Condition Scoring System		
Flaw Type	Score Deductions	Corresponding Figure
None (Looks New)	-0 pts	Figure 1
Slight Fraying	-1 pt	Figure 2
Fraying	-2 pts	Figure 3
Very Frayed	-3 pts	Figure 4
Small Rip	-1 pt	Figure 5
Ripped	-2 pts	Figure 6
Heavy Ripping	-3 pts	Figure 7
Slight Discoloration	-1 pt	Figure 8
Discoloration	-2 pts	Figure 9
Slightly Warped	-1 pt	Figure 10
Warped	-2 pts	Figure 11
Very Warped	-3 pts	Figure 12
Scratched	-1 pt	Figure 13

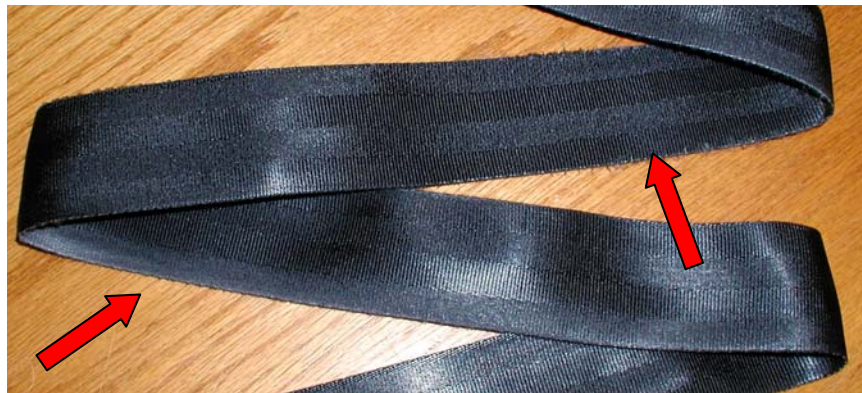
Figure 2: “Slight Fraying” – edges of webbing are partially tattered and/or worn

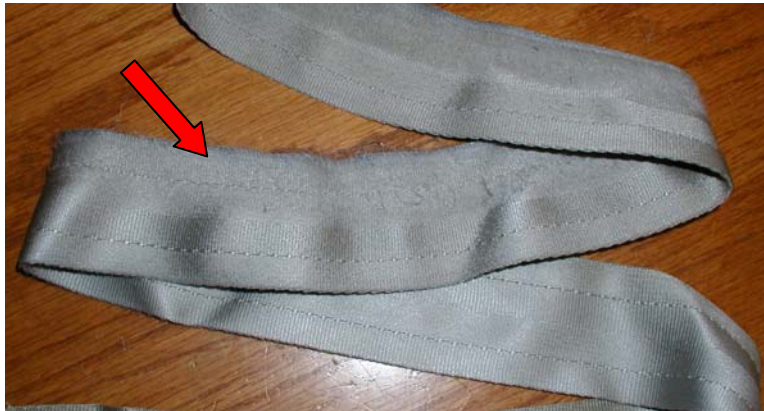
Figure 3: “Fraying” – exterior and/or edges of webbing are tattered or worn and damaged

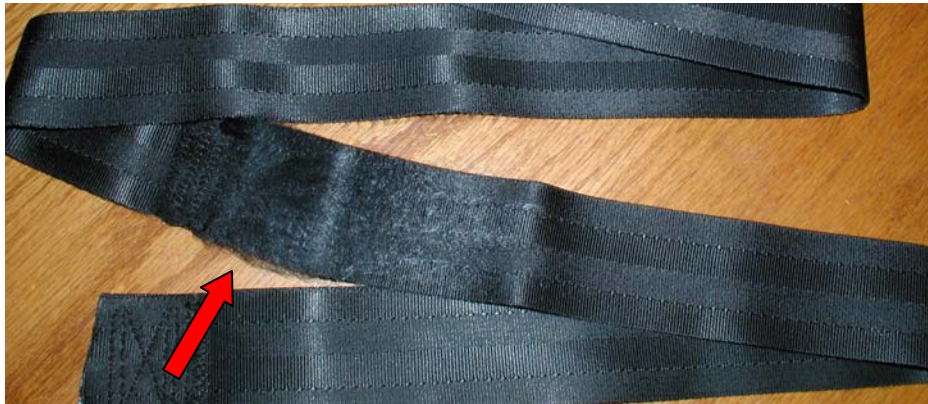
Figure 4: “Very Frayed” – exterior of webbing is substantially worn and damaged

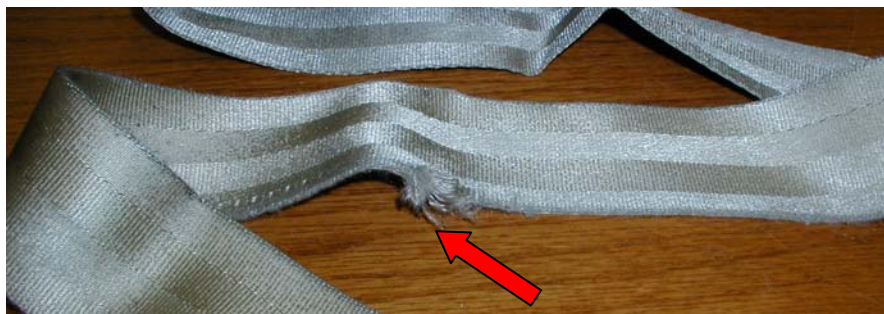
Figure 5: “Small Rip” – torn less than 0.5 inches on edge of webbing

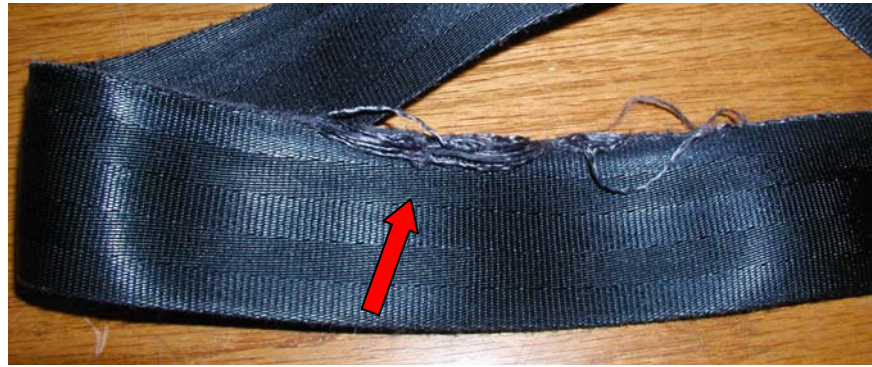
Figure 6: “Ripped” – torn between 0.5 and 3 inches on edge of webbing

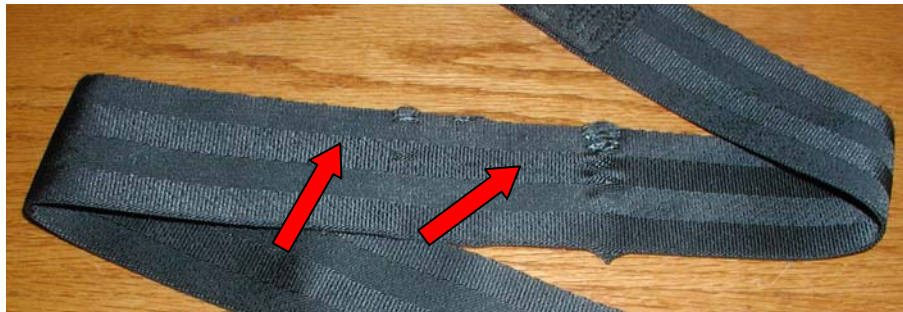
Figure 7: “Heavy Ripping” – tear exceeding 3 inches on edge of webbing or multiple tears exceeding 0.5 inches throughout webbing

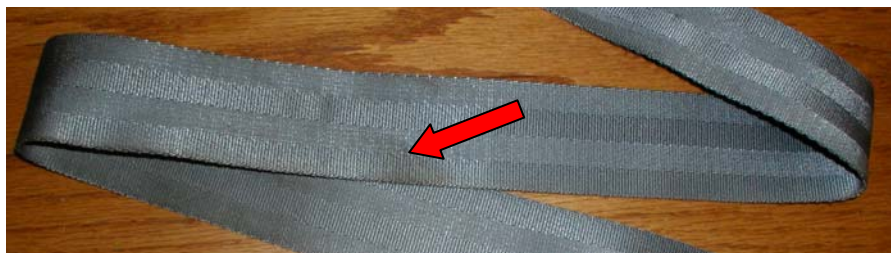
Figure 8: “Slight Discoloration” – small amount of dirt or fading color

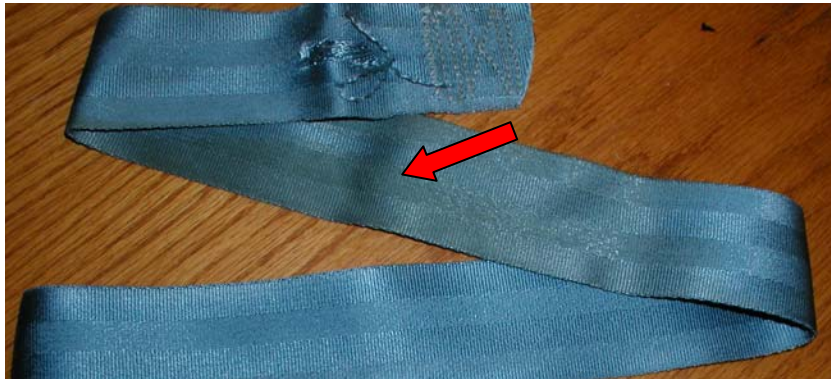
Figure 9: “Discoloration” – fair amount of dirt or fading color

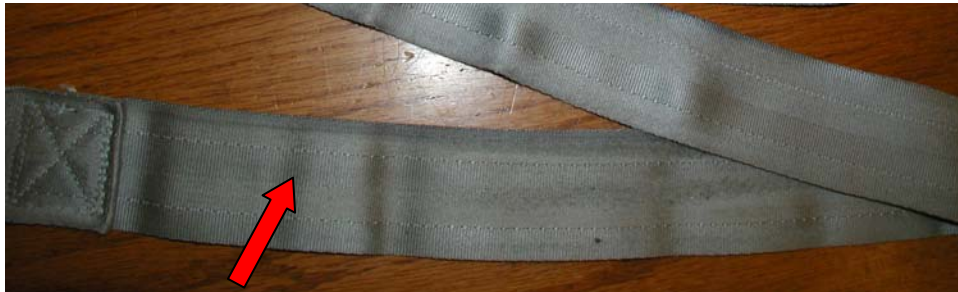
Figure 10: “Slightly Warped” – small amount of webbing curvature
(usually occurs with small fraying along one side)

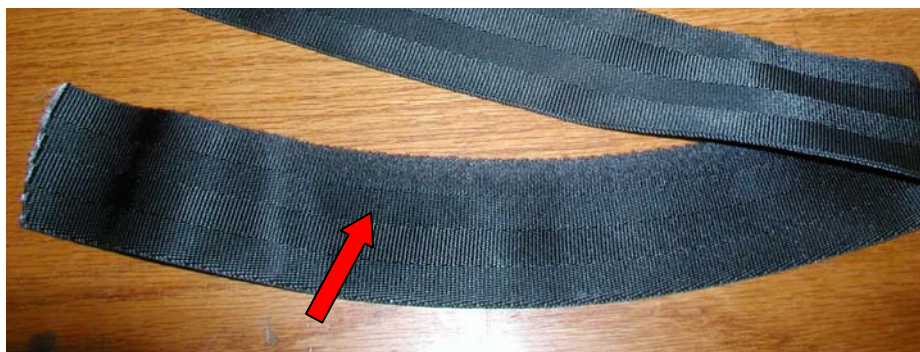
Figure 11: “Warped” – fair amount of webbing curvature
(usually occurs with fraying along one side)

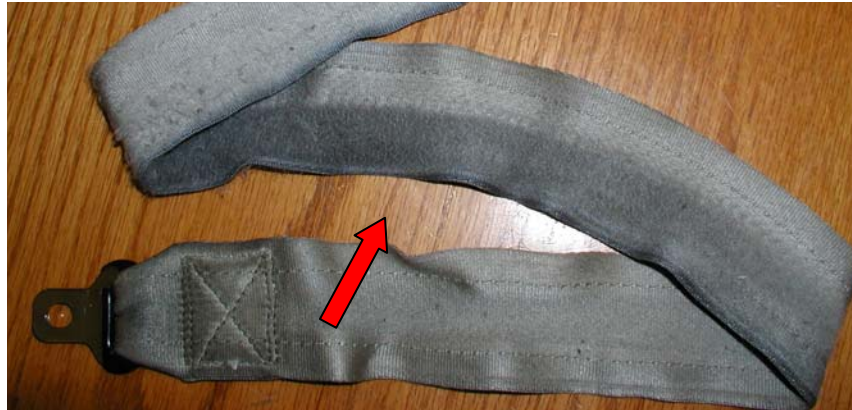
Figure 12: “Very Warped” – large amount of webbing curvature (usually occurs with very frayed sides and sometimes with discoloration)

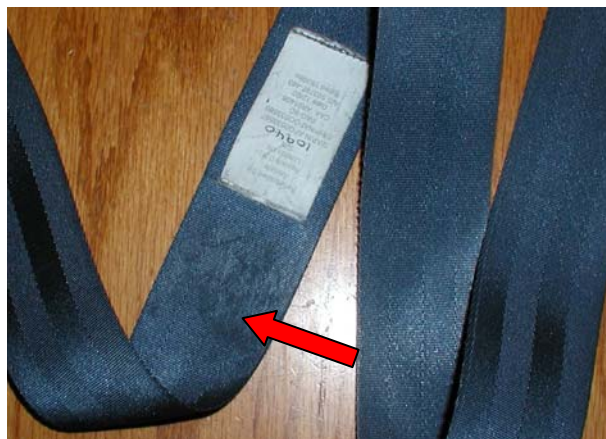
Figure 13: “Scratched” – minor surface scratches and scuffs on webbing exterior

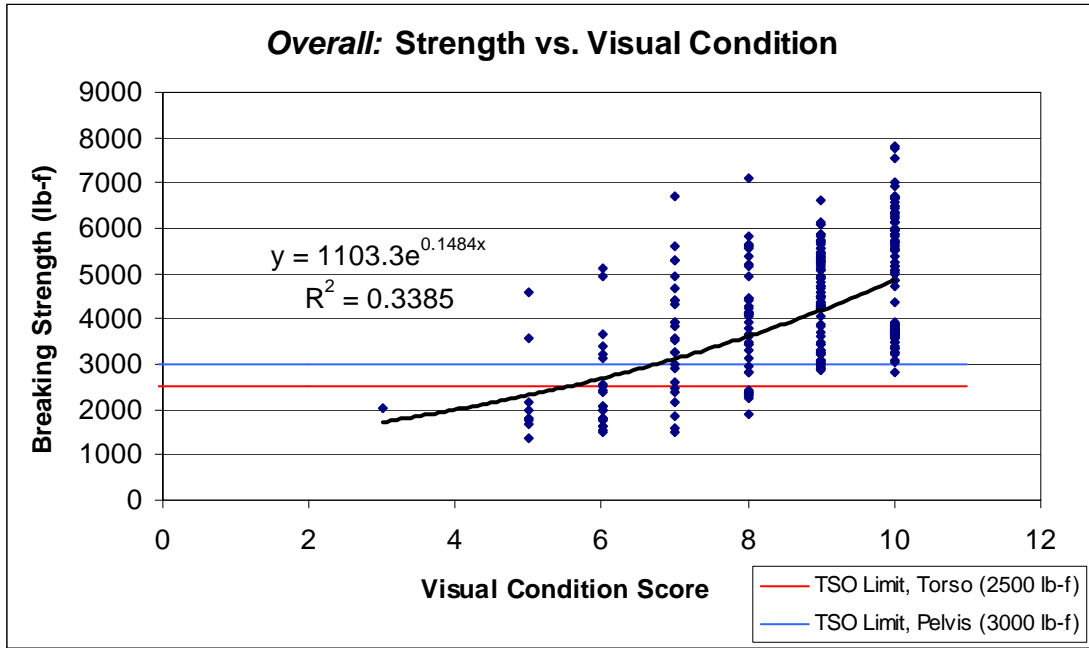
Figure 14: Overall Strength vs Visual Condition

Figure 14 shows the webbing breaking strength versus visual condition scores for tested samples. If the webbing sample scores 8 points or less according to Table 1, it is recommended that the old webbing should be replaced with new webbing. If the webbing scores above 8 points it will be (in most cases, but not all) considered airworthy according to TSO-C22g, TSO-C114, and SAE AS 8043 standards.

The ultimate breaking strength is proportional to the visual condition of the webbing samples.
