Sliding Carpet Repair for Commercial Aviation Aircraft

By: Stephen Hancock
Development Director
Airframe Products

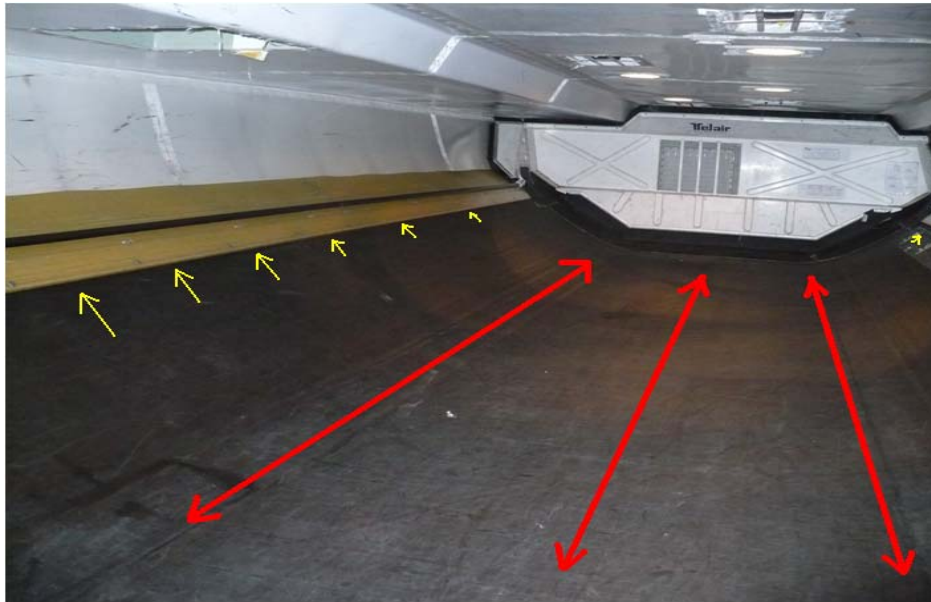
The carpet's core strength is situated along its length (referenced below by red arrows). In the event that baggage on the carpet is evenly disbursed, the effort required to operate the sliding carpet system is equivalent to the weight of the load plus the drag that the load places on the floorboards. This effort is illustrated in the picture below with the red arrows.

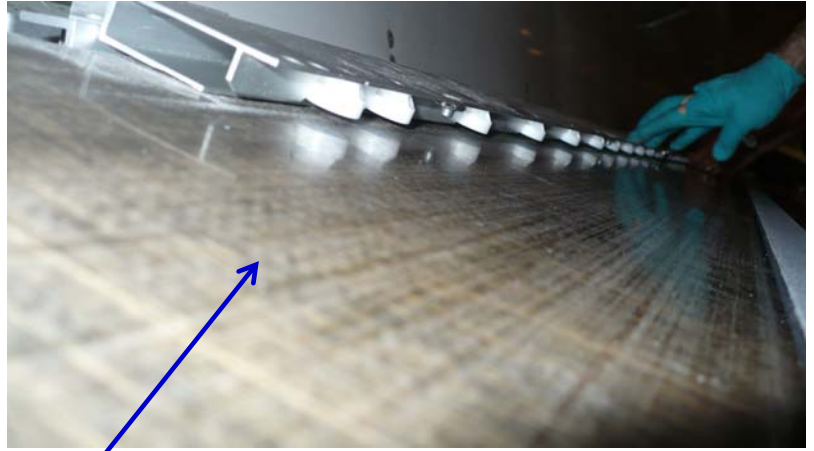
Fig. A: Guiderail under protective cover

The guide rail keeps the carpet in the normal operating position by limiting the carpets lateral movement (identified below, Fig. A).

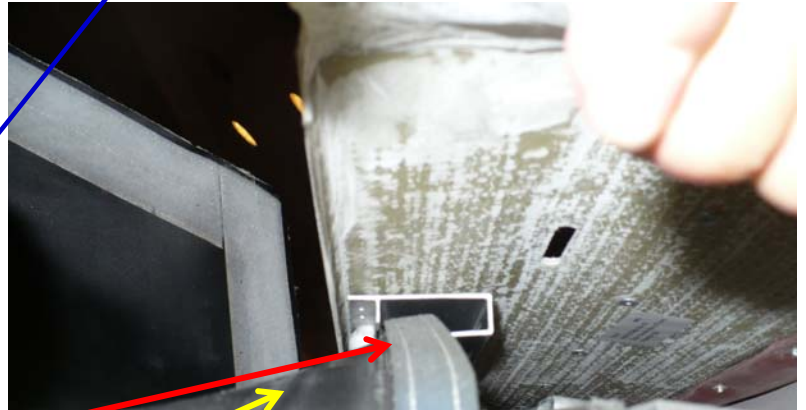
Fig. B: Urethane profile

The profile (identified below, Fig. B) slides back and forth in a guiderail. Unbalanced loading occurs when heavier objects are not evenly distributed across the width of the carpet which may result in the carpet pulling out of the guide rail and causing damage to either the guiderail, carpet or both (identified below, Fig. C)

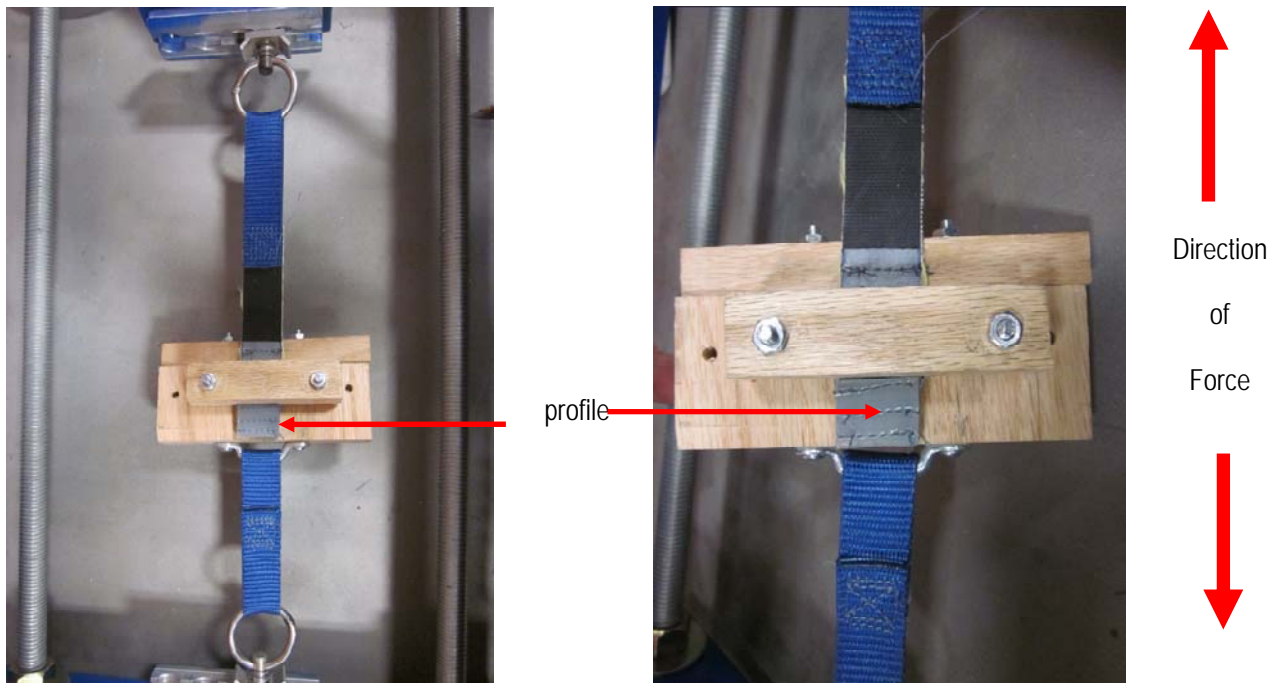
The test fixture was designed so the carpet would not bind in the test fixture and allowed for free movement of the sample.

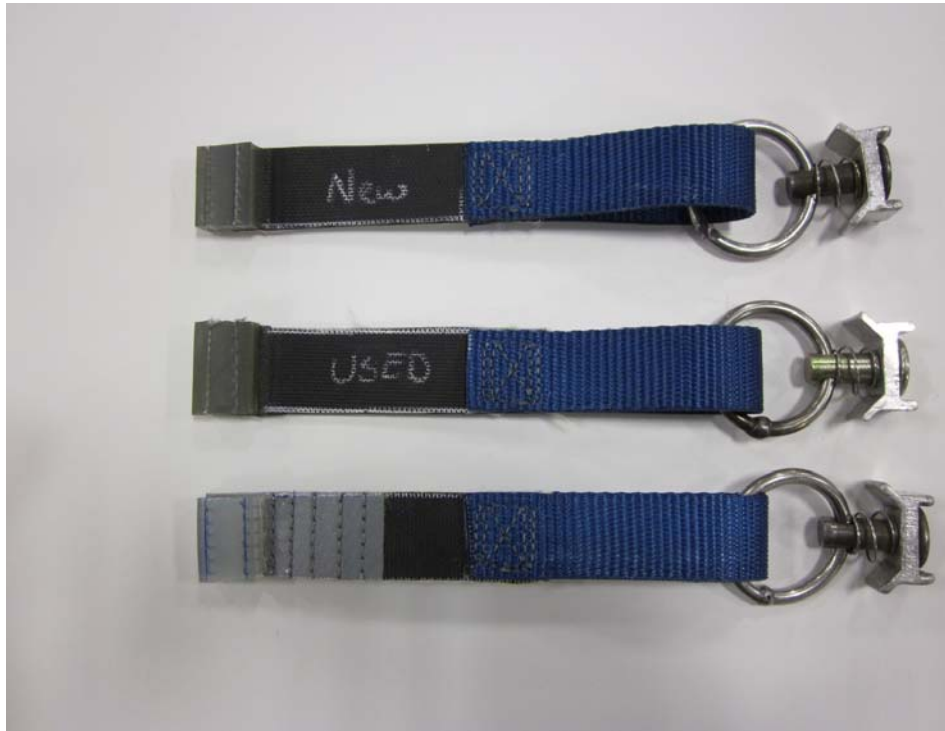
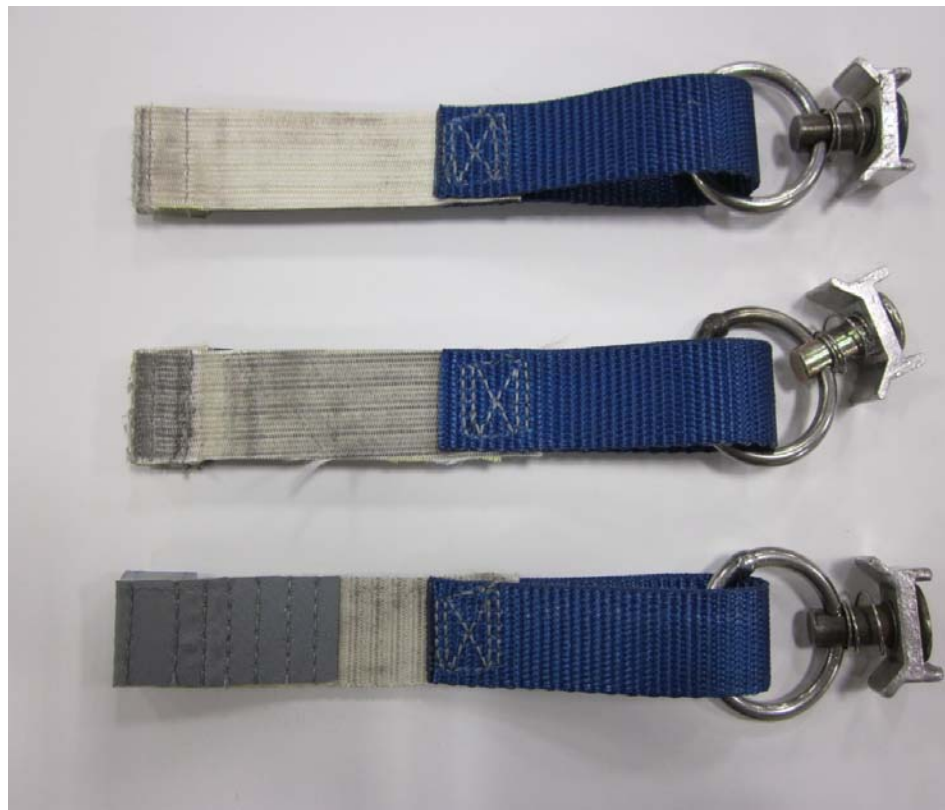
Test samples before pull testing. (Top to bottom – New, Used, and Repaired)
