SERVICE BULLETIN

CAPTURE OF POTENTIAL LOOSE FASTENERS ON INERTIA REELS

ATA 25-10-01

SB501583-25-01, Issue: 3
Page: 1 of 12
Date: 29-May-2018

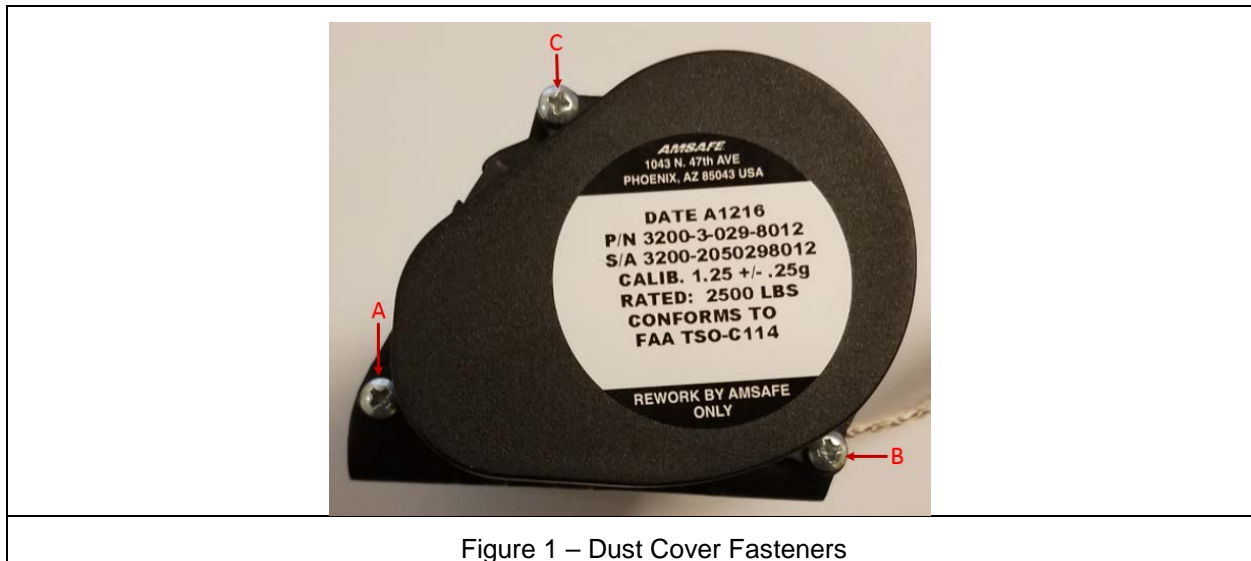
Figure 1 – Dust Cover Fasteners

The manufacturer has observed that a possibility exists where a fastener holding the inertia reel dust cover may become unattached from the inertia reel frame. This is not a safety issue, as the loss of a screw does not impact the performance of the retractor.

1. Identify the subject fasteners that hold the dust cover in place, as seen in Figure 1 below, indicated by letters 'A', 'B' and 'C'.

- Place a small strip of Torque Seal across each fastener and plastic dust cover attach points. Ideally, the strip should contact one metallic point on the frame, but it is not absolutely necessary for this Service Bulletin to be effective. Figures 2 and 3 show the Torque Seal applied.
