SERVICE BULLETIN

Equipment/Furnishings
Passenger Compartment

CAPTURE OF POTENTIAL LOOSE FASTENERS ON INERTIA REELS

SB501583-25-01, Issue: 4
Page: 1 of 12
Date: 20-Aug-2018

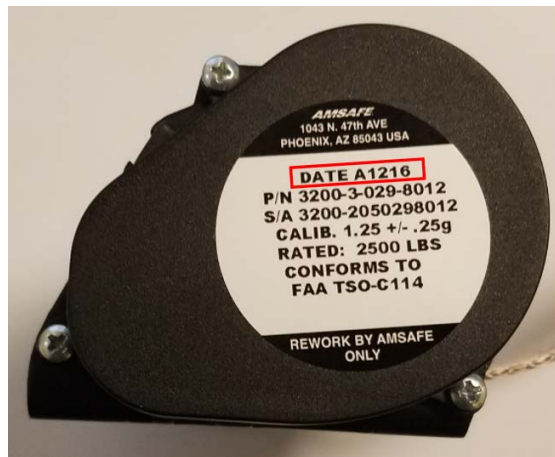
Figure 1: Date Code Location

1. Identify the date code on the retractor. It will be located on the decal as seen in Figure 1 below. The date code will consist of a Letter followed by a two-digit month and a two-digit year. As an example, the date code for a retractor built in April of 2018 would have the last four-digits as 0418.

If the retractor is built on or before April 2018, continue onto step 2. If the retractor was built after April 2018, this Service Bulletin does not apply.

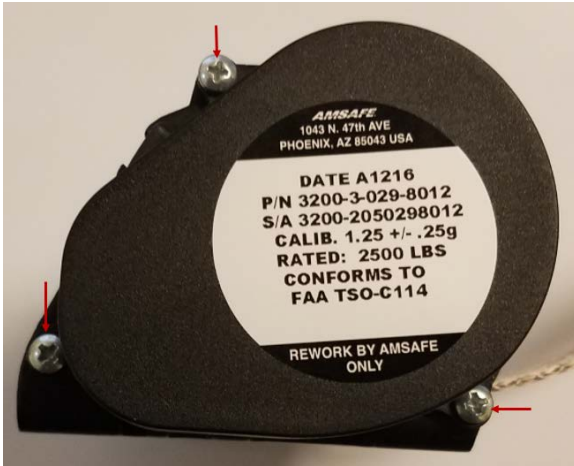
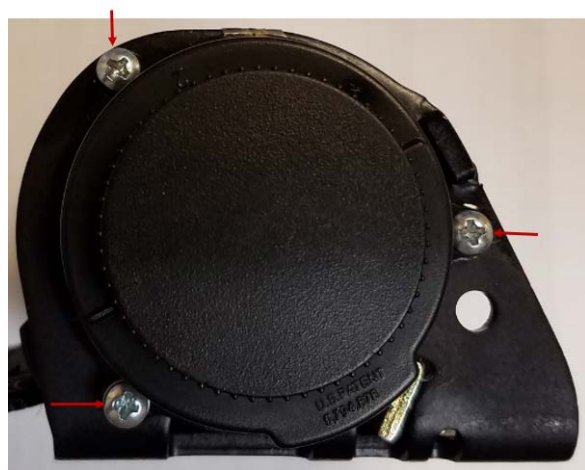
Figure 2: Fastener Locations

The manufacturer has observed that a possibility exists where a fastener holding the inertia reel dust cover may become unattached from the inertia reel frame. This is not a safety issue, as the loss of a screw does not impact the performance of the retractor.

- Identify the subject fasteners that hold the dust cover and spring cup in place, as seen in Figure 2 below.

Dust Cover Fasteners

Spring Cup Fasteners

- Place a small strip of Torque Seal across each fastener. Ideally, the strip should contact one metallic point on the frame, but, at a minimum, the Torque Seal must contact at least the screw and plastic cover for this Service Bulletin to be effective. Figures 3 and 4 show the Torque Seal applied. The same torque seal application should be performed to both the dust cover and spring cup fasteners.
