SERVICE BULLETIN

Inspection, Check and Replacement of Hook Assembly P/Ns 505960-401 and 502737-459

ATA 25-20-01 and 25-10-01

SB505960-01, Issue: 5
Page: 1 of 13
Date: 06-Aug-2018

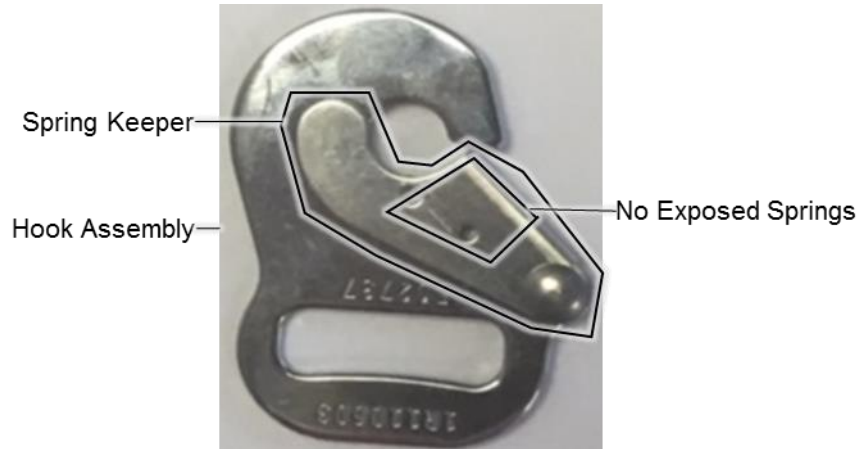
Step a. If the hook assembly on the connector half and the buckle half does not have exposed springs (Figure 1) you are done with this service bulletin.

Figure 1 – Hook Assembly Without Exposed Springs

Restraints without exposed springs (Figure 1) weigh 6 grams more than restraints with exposed springs (Figure 2).

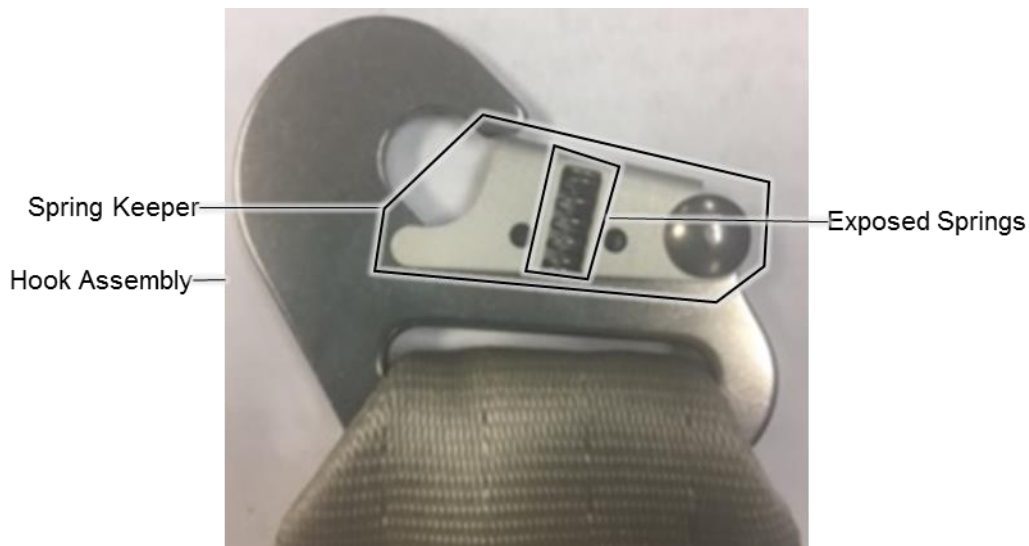
Step b. If the hook assembly has exposed springs (Figure 2) proceed with this service bulletin.

Figure 2 – Hook Assembly With Exposed Springs

Hook assemblies with exposed springs are subject to damage (e.g. compressed springs, bends, rotation or deformation).

Interchanging or intermixing restraints is not allowed. Restraints with exposed springs on the hook assembly must be returned to AmSafe.

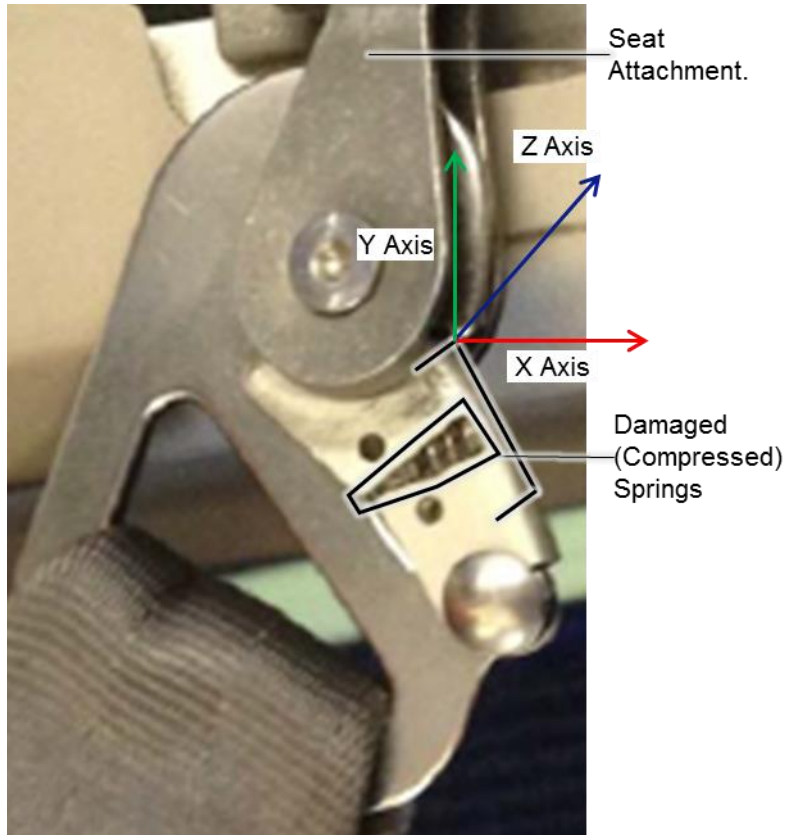
RC Step 2. Visually examine the hook assembly for damage (e.g., compressed springs, bends, rotation or deformation of the bridge along the X axis, Y axis or Z axis) that would restrict movement or function (Figure 3 and Figure 4).

Figure 3 – Damaged Hook Assembly

Step b. If there is evidence of damage a functional check is not required.

Step i. Return the restraint to AmSafe by following the instructions in section 2.1 and by following the shipping and handling instructions in the ICA or CMM.

Step ii. Upon receipt of a new restraint from AmSafe, install the new restraint following the instructions in the ICA or CMM.

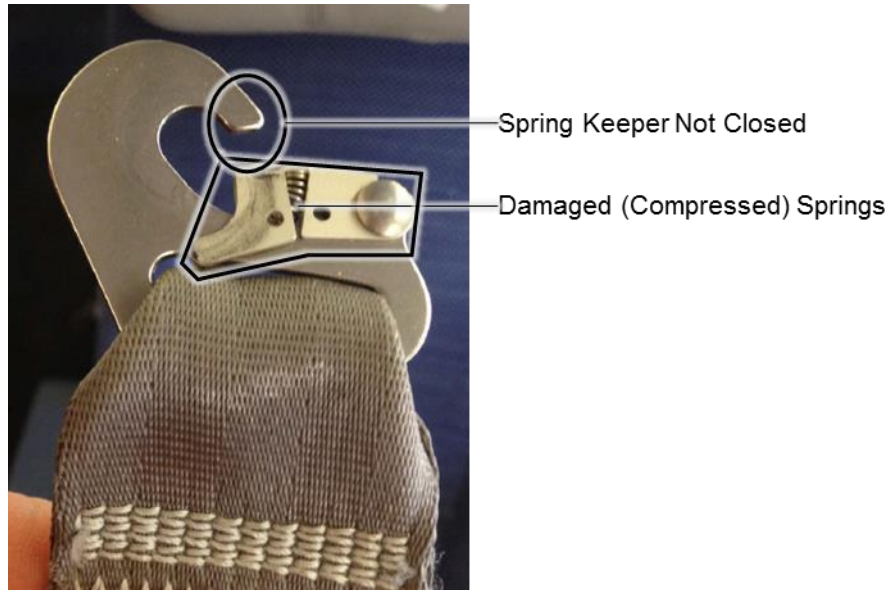
Figure 4 – Damaged Hook Assembly

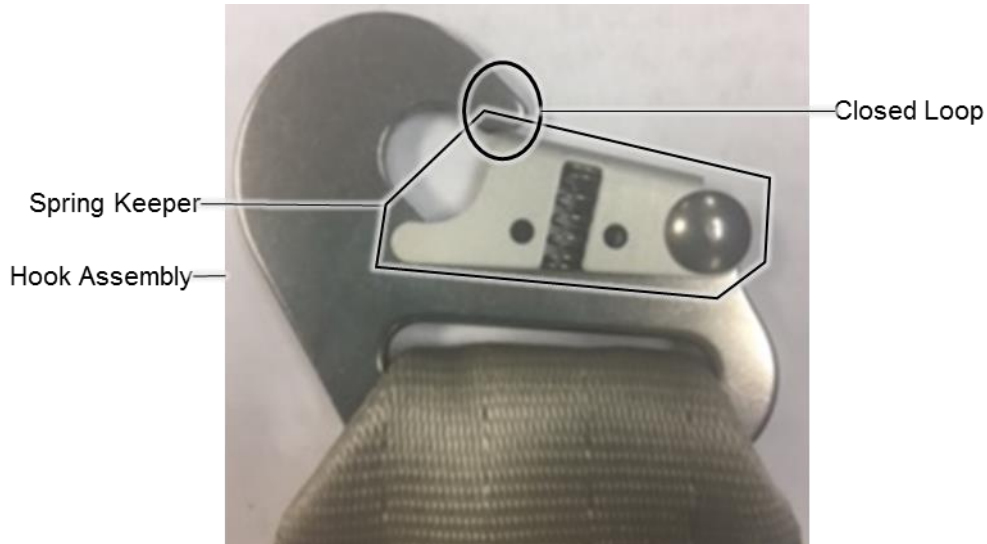
Step b. The spring keeper should return to a closed position. The closed position is achieved when the spring is firmly engaged/pressed and the keeper is against the hook, creating “closed loop” (Figure 5). There should be no deformation or damage preventing the spring keeper from returning to a closed position.

Figure 5 – Spring Keeper and Closed Loop

- Step c. If the spring keeper easily compresses and releases and returns to the closed position the functional check is complete.
- Step d. If the spring keeper does not easily compress and release, or the spring keeper does not return to a closed position, return the restraint to AmSafe.
- Step i. Return the restraint to AmSafe by following the instructions in section 2.1 and by following the shipping and handling instructions in the ICA or CMM.
- Step ii. Upon receipt of a new restraint from AmSafe, install the new restraint following the instructions in the ICA or CMM.
