SERVICE LETTER

Buckle/Connector Assembly Plug, P/N 502913
Inspection and Removal

Cirrus Aircraft, SR2X, 7041-() Inflatable
Restraint System Assembly

SL 7041, Issue: 1
Page: 1 of 7
Date: 24-Apr-2023

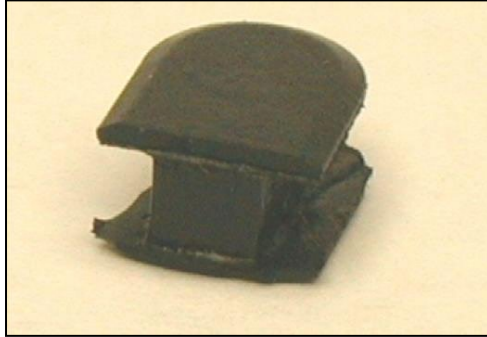
Figure 1. Plug (P/N 502913)

1. Plug P/N 502913, qty. 2 per restraint system. See Figure 1.

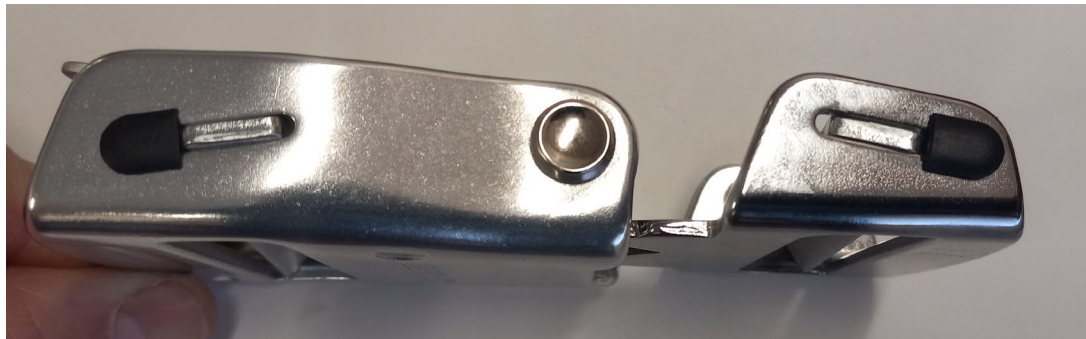
Figure 2. Buckle/Connector with Incorrect Plug Installation

Customers have reported an in-service problem of incorrectly installed or missing plugs found on the belt buckle assemblies.

2. Locate and inspect the buckle/connector assembly. If plug is installed incorrectly (as shown below), remove the plug using hand tools as needed.

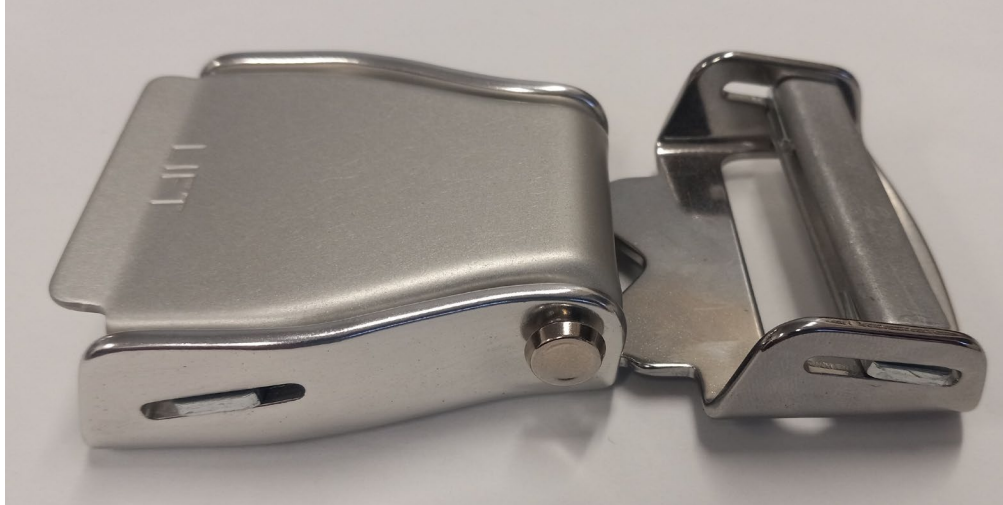
Figure 3. Buckle/Connector Before Plug Installation

3. Review Figure 3 for detail on where the plug is installed.
 - Slide the load bar (part which webbing wraps around) towards the webbing straps and hold it there while installing the plug.

- With the lot number on the plug facing inward lay the plug in the slot in the side of the buckle or connector lengthwise at an angle. The plug should be inserted into the end of the slot farthest from the webbing, and the curved end of the plug should face away from the webbing.

- With a small screwdriver, gently press in the center of the plug so that the lip of the plug comes through on the other side. (Note: use only enough pressure to make the lip of the plug pop through to the opposite side)

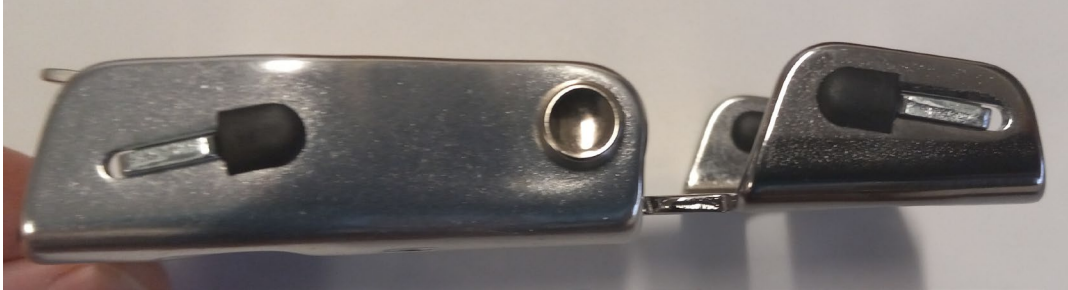
Figure 4. Buckle/Connector with Plug Installed

- Secure the plug with your finger to prevent the plug from disengaging out of the slot.
 - Ensure the plug is completely seated in the slot, and the lips on the plug are completely through the other side of the slot. See Figure 4.

- Repeat for the opposite side of the buckle/connector. Plugs must be installed in pairs, two per buckle.
- Inspect plugs for correct installation location per Figure 4 and Figure 5

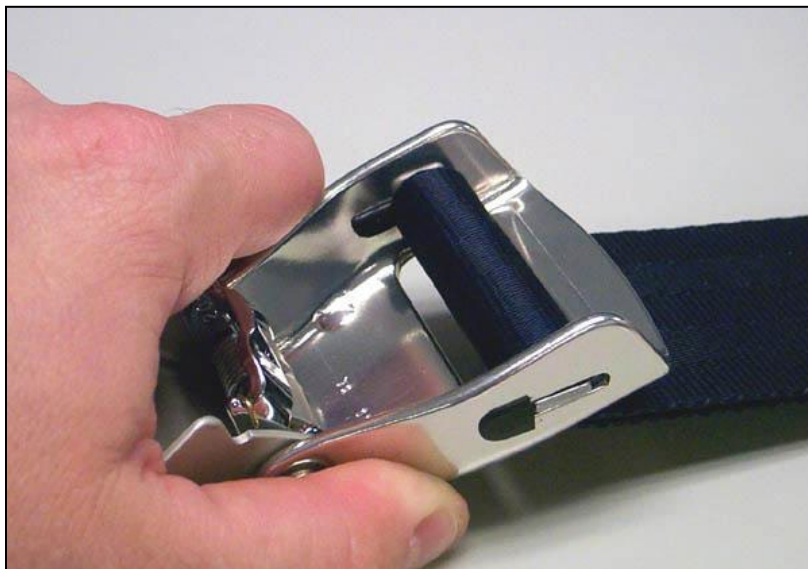
Figure 5. Buckle with Plug Installed and Cover Open Showing Inside of Buckle

NOTE: Be sure to install the plug in the correct location. If installed incorrectly, the buckle/connector assembly will not function properly.
